## ABSTRACT

This document describes the known exceptions to the functional specifications (advisories).

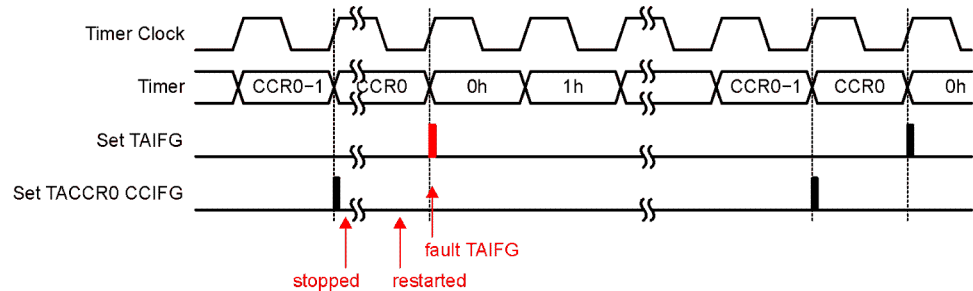
<b>Workaround</b>	None
<b>TA21</b>	<b>TA Module</b>
<hr/>	
<b>Category</b>	Functional
<b>Function</b>	TAIFG Flag is erroneously set after Timer A restarts in Up Mode
<b>Description</b>	In Up Mode, the TAIFG flag should only be set when the timer counts from TACCR0 to zero. However, if the Timer A is stopped at TAR = TACCR0, then cleared (TAR=0) by

setting the TACLK bit, and finally restarted in Up Mode, the next rising edge of the TACLK will erroneously set the TAIFG flag.

**Workaround** None.

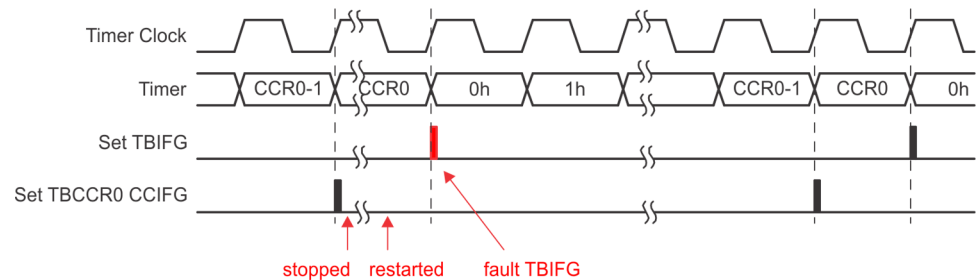
<b>Category</b>	Functional
<b>Function</b>	TBIFG Flag is erroneously set after Timer B restarts in Up Mode
<b>Description</b>	In Up Mode, the TBIFG flag should only be set when the timer resets from TBCCR0 to zero. However, if the Timer B is stopped at TBR = TBCCR0, then cleared (TBR=0) by setting the TBCLR bit, and finally restarted in Up Mode, the next rising edge of the TBCLK will erroneously set the TBIFG flag.

<b>Workaround</b>	None.
-------------------	-------
