Errata  
**MSP430F5438 Microcontroller**

**ABSTRACT**

This document describes the known exceptions to the functional specifications (advisories).

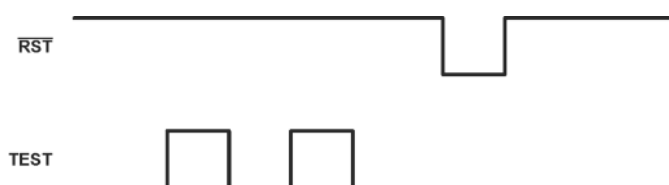
- Toggle the TEST pin twice when nRST is high and after 50us pull nRST low.

Note: This toggling of TEST pins is not subject to timing constraints. The appropriate level transitions on TEST pin, followed by a RST pulse after 50us, are sufficient to trigger an exit from BSL mode.
