MSP430FG4270 Device Erratasheet

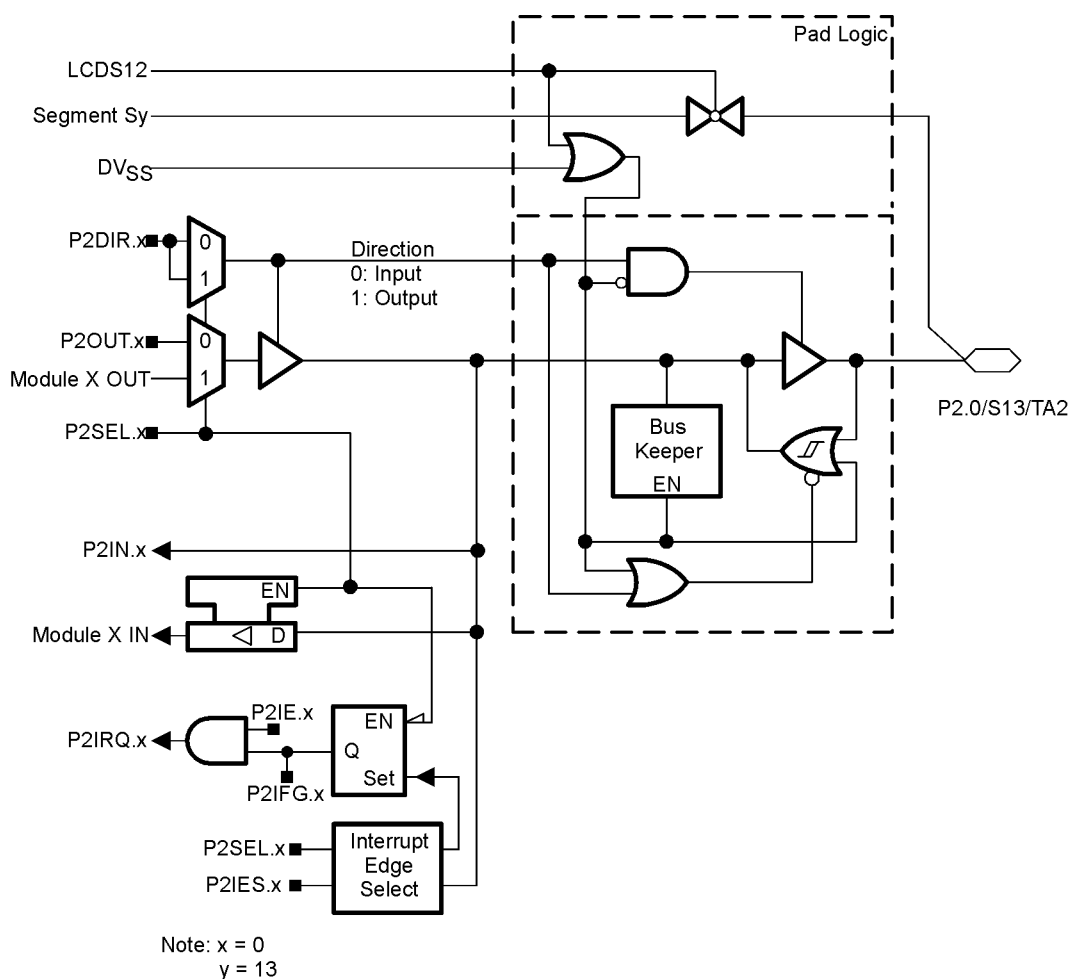
PORT6 *PORT Module*

Function P2.0 module function

Description In addition to GPIO and LCD functionality, P2.0 also has Timer_A3 module output capability. When $\text{P2SEL.0} = 1$ and $\text{P2DIR.0} = 1$, P2.0 becomes a TA2 output.
