# MSP430FW423 Device Erratasheet

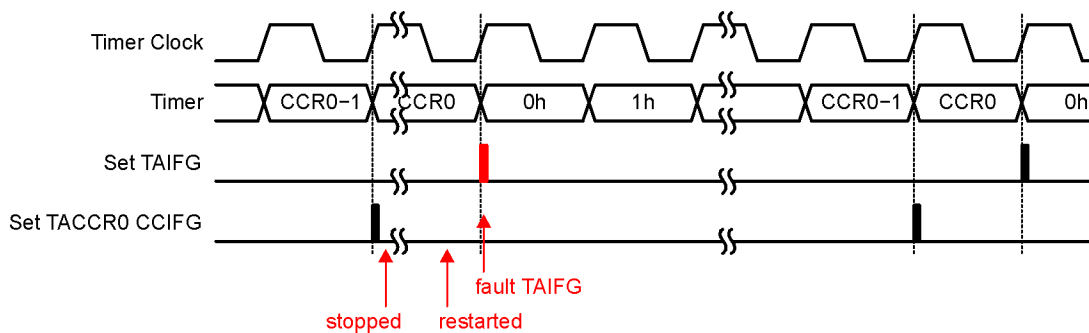
**TA21** *TIMER\_A Module*

**Function** TAIFG Flag is erroneously set after Timer A restarts in Up Mode

**Description** In Up Mode, the TAIFG flag should only be set when the timer counts from TACCR0 to zero. However, if the Timer A is stopped at TAR = TACCR0, then cleared (TAR=0) by setting the TACLK bit, and finally restarted in Up Mode, the next rising edge of the TACLK will erroneously set the TAIFG flag.

**Workaround** None.
