# Errata

## **MSP430G2101 Microcontroller**

This document describes the known exceptions to the functional specifications (advisories).

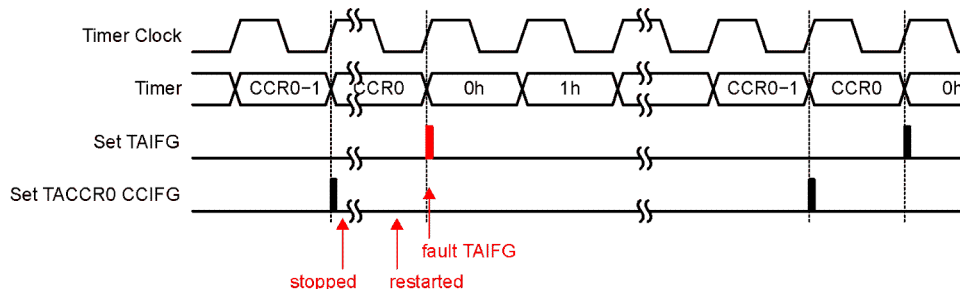
**TA21** *TA Module*

**Function** TAIFG Flag is erroneously set after Timer A restarts in Up Mode

**Description** In Up Mode, the TAIFG flag should only be set when the timer counts from TACCR0 to zero. However, if the Timer A is stopped at TAR = TACCR0, then cleared (TAR=0) by setting the TACLRL bit, and finally restarted in Up Mode, the next rising edge of the TACLK will erroneously set the TAIFG flag.

**Workaround** None.
