**TMS320C6671**  
**Multicore Fixed and Floating-Point Digital**  
**Signal Processor**  
**Silicon Revision 1.0, 2.0**

**Silicon Errata**

Literature Number: SPRZ366H  
October 2011–Revised June 2015

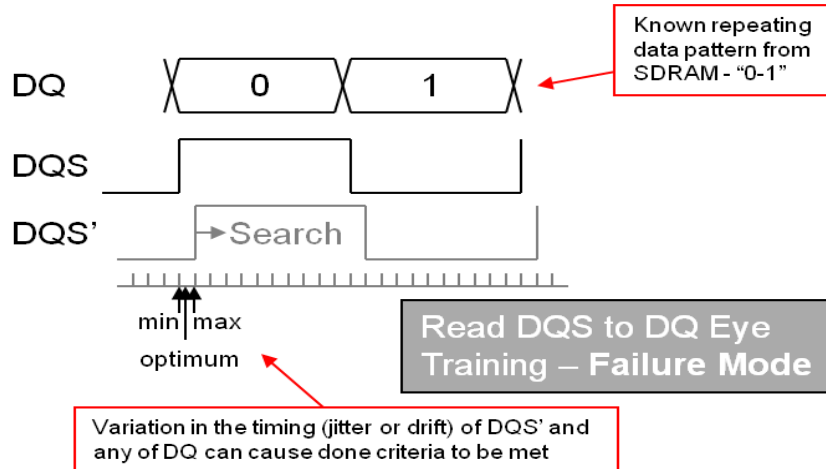
Figure 4. Read DQS to DQ Eye Training - Failure Mode

The leveling feature with the problem is the Read Data Eye Training. Depending on the jitter seen on the DQ and DQS signals, this leveling feature will fail to converge on a good data eye, resulting in corrupted DSP to DDR3 SDRAM reads.

However, if too much jitter is present on the DQ or DQS signals, the search can converge to a false edge as shown in Figure 4.

**Workaround 1:**

This mode is enabled by setting bit 9 (0-indexed) of the DDR3\_CONFIG\_REG\_23 at address 0x02620460. The lower 8 bits (bits 7:0) must not be overwritten and will contain their default value of 0x34. The default value is recommended for use. After programming DDR3\_CONFIG\_REG\_23, proceed to enable auto-leveling. Please refer to the *DDR3 Initialization Application Report* ([SPRABL2](#)) for details of the sequence of steps.
