AM572x Sitara™ Processors Silicon Revisions 1.1, 2.0

Errata

Literature Number: SPRZ429N
JULY 2014 – REVISED JULY 2024

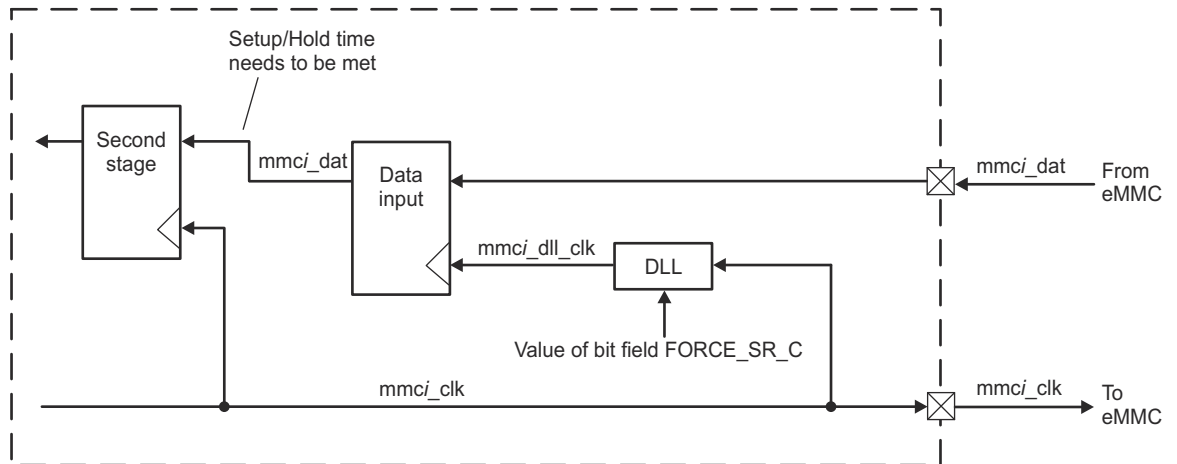
Figure 2-2. Simplified SoC 192-MHz Mode DLL Block Diagram

DESCRIPTION Internal to the MMC module, a second stage latch is used to recapture data captured by DLL delayed CLK, MMC_DLL_CLK. The second stage latch captures with the original transmitting clock, MMC_CLK.

MMC_DLL_CLK and MMC_CLK both run at the same clock frequency. This results in a narrow range of tuning ratio elements, where the delayed MMC_DLL_CLK comes in phase with MMC_CLK. If the clocks are in phase, the data captured by the first clock violates the setup and hold time requirements needed for the second stage latch, resulting in incorrectly read data. This is known as tuning re-timing errors.

A DLL tuning algorithm has been implemented that can avoid the tuning re-timing errors. More details on this can be found in App Note [SPRACA9](#). The following notes summarize the updated algorithm:

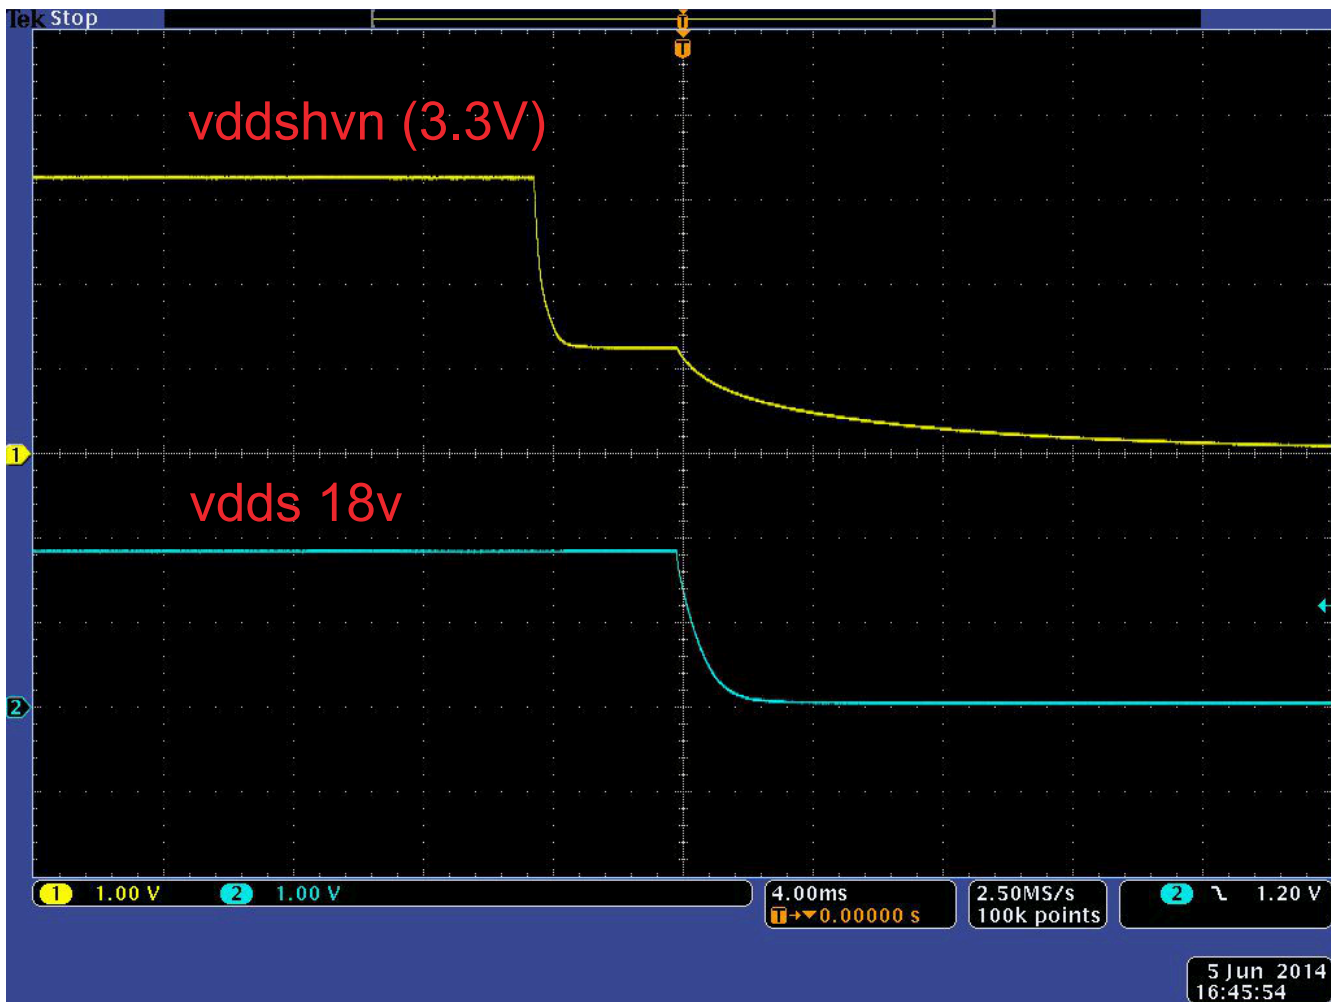
Figure 4-1. PAB_RevA

The Data Manual allows the vddshvn rail (in either 3.3V or 1.8V mode) to power down at the same time or before the vdds18v rail. When the vddshvn rail is powered down before the vdds18v rail, the vddshvn rail stays at Plateau Level (<1.5V) until the vdds18v rail is disabled, as shown in the waveform below.

A subset of the SOC's LVCMOS IOs (refer to DM for details) have a pull-up resistor that is active by default, including during reset and power-down. The SOC's IOs that have internal or external pull-ups will stay at Plateau Level (<1.5V) during the power-down. If other ICs on the board that are interfaced to the SOC's LVCMOS signals use a separate supply then it's possible that the other IC's signals can be pulled to the Plateau Level while its power supply is off.

The root cause of the plateau is related to the LVCMOS IO buffer Dual Voltage detection circuitry. The LVCMOS Dual Voltage IO includes voltage comparator circuitry to determine

In general, TI recommends using the same supply source for connected components. E.g., a single LDO should drive vddshvn and the related 3.3V external components.

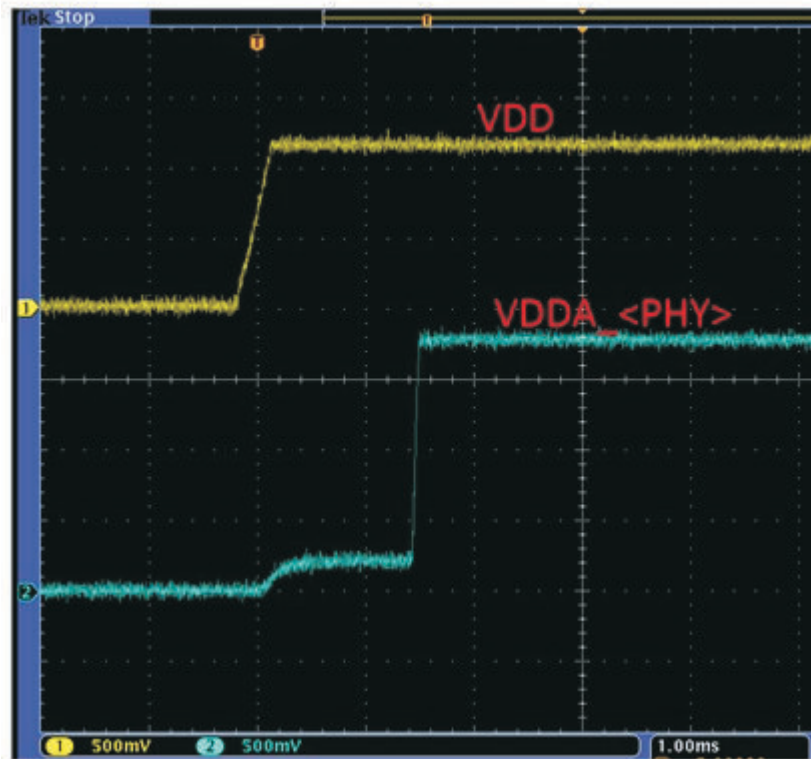
Figure 4-2. Leakage Voltage

A current path exists between VDD and the high speed analog PHY domain (VDDA_HDMI, VDDA_PCIE, VDDA_SATA, VDDA_USB2/3) during the supply power up and power down sequences.

The device-specific Data Manual requires Core AVS rail (VDD) to power up before the 1.8 V high speed analog PHY domain(s). When this sequence is followed, the high speed analog PHY domain will have a small step-up to a voltage plateau (< 0.5 V) that aligns to the beginning of the VDD ramp-up, and is maintained until the ramp-up of high speed analog PHY rail, as shown in [Figure 4-2](#). Note the leakage value will differ from system to system, but will be less than 500 mV. The leakage voltage in the provided capture is approximately 250 mV.

A similar condition exists during supply power down sequence. The high speed analog PHY domain(s) are required to be powered down prior to Core AVS rail (VDD), and may cause a small plateau to exist until Core AVS rail (VDD) is ramped down.

The root cause of the voltage plateau during power-up/down sequencing is related to the parasitic diodes in logic blocks which have multiple power sources. This leakage path is not a reliability concern for this device.
