**ABSTRACT**

This document describes the known exceptions to the functional specifications (advisories).

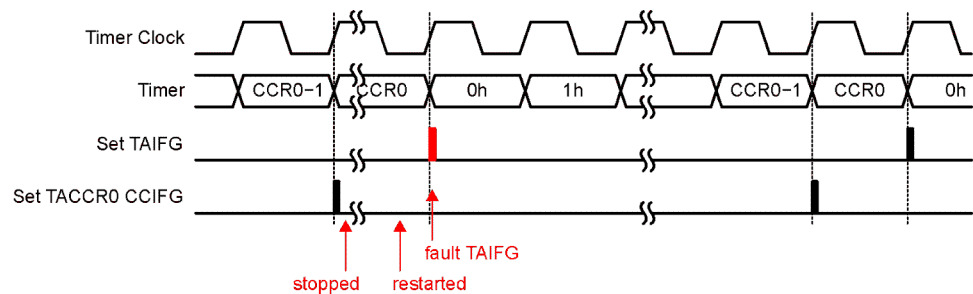
In Up Mode, the TAIFG flag should only be set when the timer counts from TACCR0 to zero. However, if the Timer A is stopped at TAR = TACCR0, then cleared (TAR=0) by setting the TACLr bit, and finally restarted in Up Mode, the next rising edge of the TACLK will erroneously set the TAIFG flag.

None.
