## ABSTRACT

This document describes the known exceptions to the functional specifications (advisories).

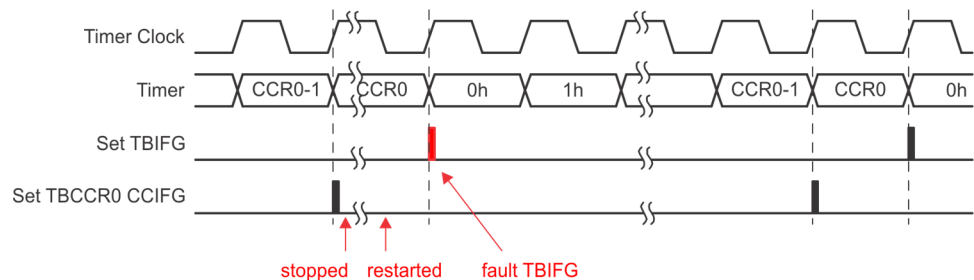
**TB24** *TB Module*

**Function** TBIFG Flag is erroneously set after Timer B restarts in Up Mode

**Description** In Up Mode, the TBIFG flag should only be set when the timer resets from TBCCR0 to zero. However, if the Timer B is stopped at TBR = TBCCR0, then cleared (TBR=0) by setting the TBCLR bit, and finally restarted in Up Mode, the next rising edge of the TBCLK will erroneously set the TBIFG flag.

**Workaround** None.
