## ABSTRACT

This document describes the known exceptions to the functional specifications (advisories).

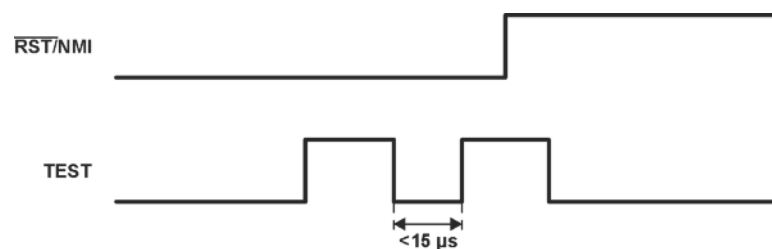
The BSL entry sequence requires that the low phase of the TEST/SBWTCK pin does not exceed 15 $\mu$ s. This timing requirement is faster than most PC serial ports can provide, as shown in the following picture. If this requirement is not met, the entry sequence fails and the SYSBSLIND is not set.

**Workaround** An external hardware solution is recommended to provide the appropriate BSL entry sequence. See [http://processors.wiki.ti.com/index.php/BSL\\_\(MSP430\)](http://processors.wiki.ti.com/index.php/BSL_(MSP430)) for recommendations on available BSL hardware.
