Errata

TMS320F280x, TMS320C280x, TMS320F2801x DSPs Silicon revisions C, B, A, 0

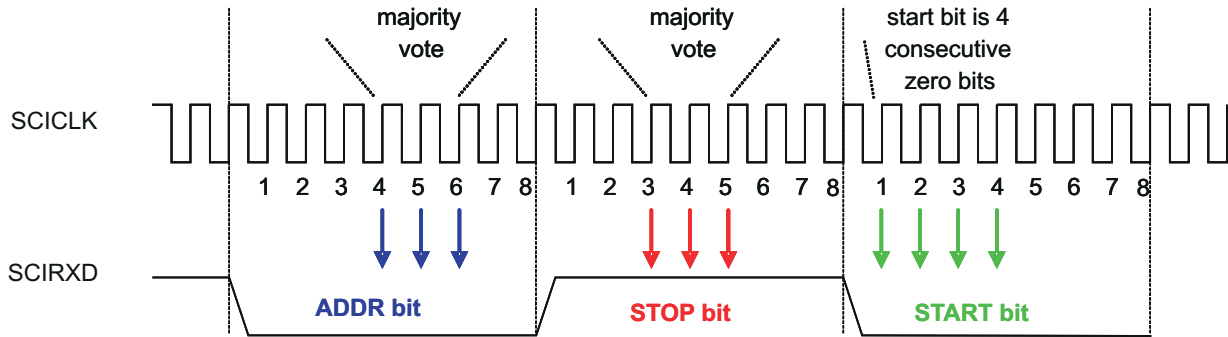
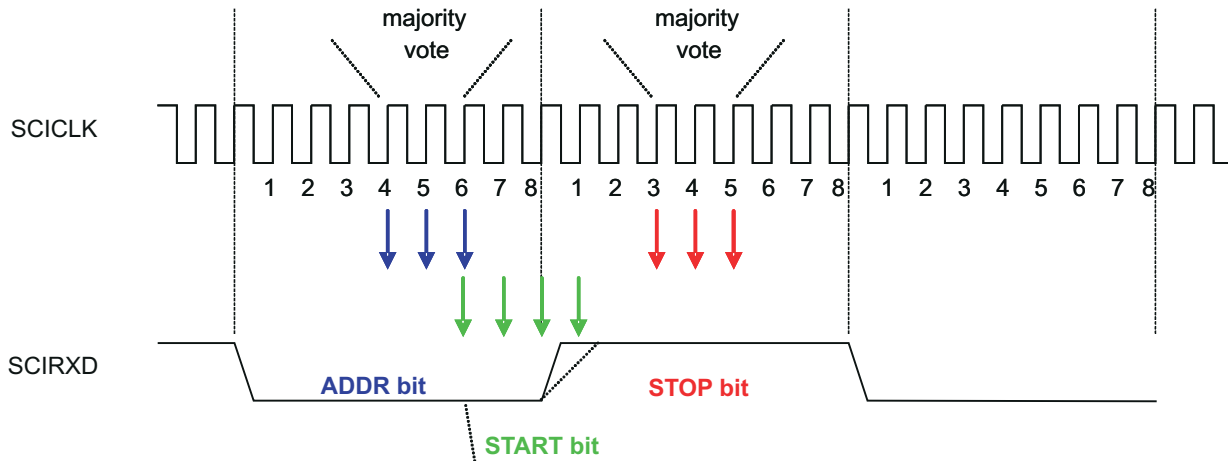
Figure 5-1. Difference Between Expected and Erroneous Operation of START Bit

Details SCI does not look for STOP bit after the ADDR bit. Instead, SCI starts looking for the start bit beginning on sub-sample 6 of the ADDR bit. Slow rise-time from ADDR to STOP bit can cause the false START bit to occur since the 4th sub-sample for the start bit may be sensed low.

Workaround(s) Program the baud rate of the SCI to be slightly slower than the actual. This will cause the 4th sub-sample of the false START bit to be delayed in time, and therefore occur more towards the middle of the STOP bit (away from the signal transition region). The amount of baud slowing needed depends on the rise-time of the signal in the system. Alternatively, IDLE mode of the SCI module may be used, if applicable.
