**TMS320C6424/21**  
**Digital Signal Processor (DSP)**  
**Silicon Revisions 1.3, 1.2, 1.1, and 1.0**

**Silicon Errata**

Literature Number: SPRZ252D  
March 2007–Revised August 2011

# **TMS320C642x DSP Silicon Revisions 1.3, 1.2, 1.1, and 1.0**

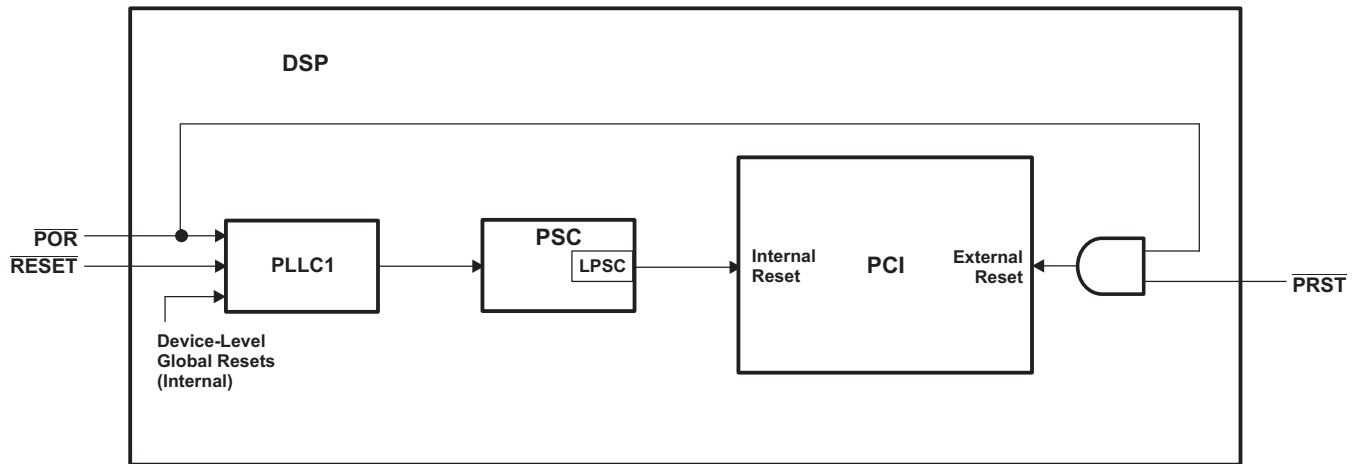
Figure 3. Internal and External Reset Inputs of the PCI Module

On all C6424 silicon revisions, the PCI module has both an internal and external reset source (see Figure 3). The external reset is asserted through *either* the PCI Reset pin ( $\overline{\text{PRST}}$ ) or the Power-On Reset pin ( $\overline{\text{POR}}$ ). The internal reset is controlled by the Local Power and Sleep Controller (LPSC) of the PCI module. The PSC asserts the internal reset of the PCI module after a device-level global reset or when the DSP code programs the PSC to do so. A device-level global reset is generated through the Power-On-Reset pin ( $\overline{\text{POR}}$ ) or the Warm Reset pin ( $\overline{\text{RESET}}$ ); however, there are other methods to generate a device-level global reset. For these other methods, see Table 4.

Systems should be designed such that a device-level global reset *a/ways* generates the PCI Reset ( $\overline{\text{PRST}}$ ) and vice-versa. The PCI module can lock-up or go into a bad state if its internal and external resets are asserted independently—meaning one is asserted and the other is not.

Figure 4 and Figure 5 show example circuits which ensure both the device-level global reset and the PCI Reset ( $\overline{\text{PRST}}$ ) are asserted together.

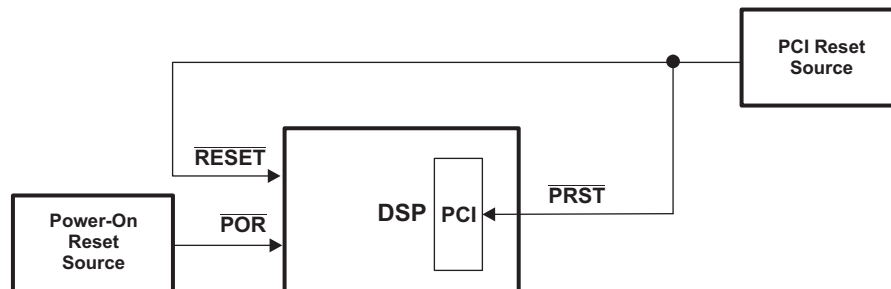
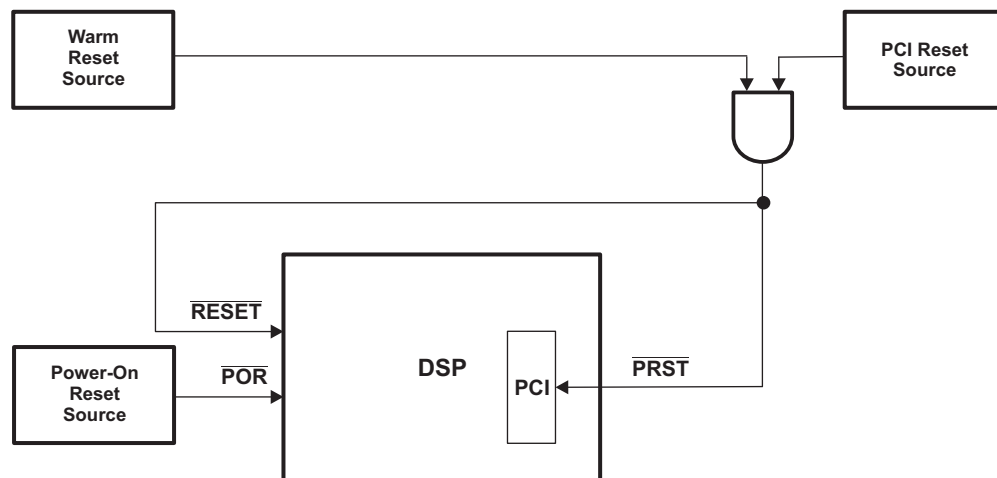
In [Figure 4](#) and [Figure 5](#) a device-level global reset resets the DSP and the PCI module only; other devices on the PCI bus *will not* be reset. To avoid interrupting any ongoing PCI transactions to/from the DSP, the DSP PCI should be "disconnected" from the PCI system.

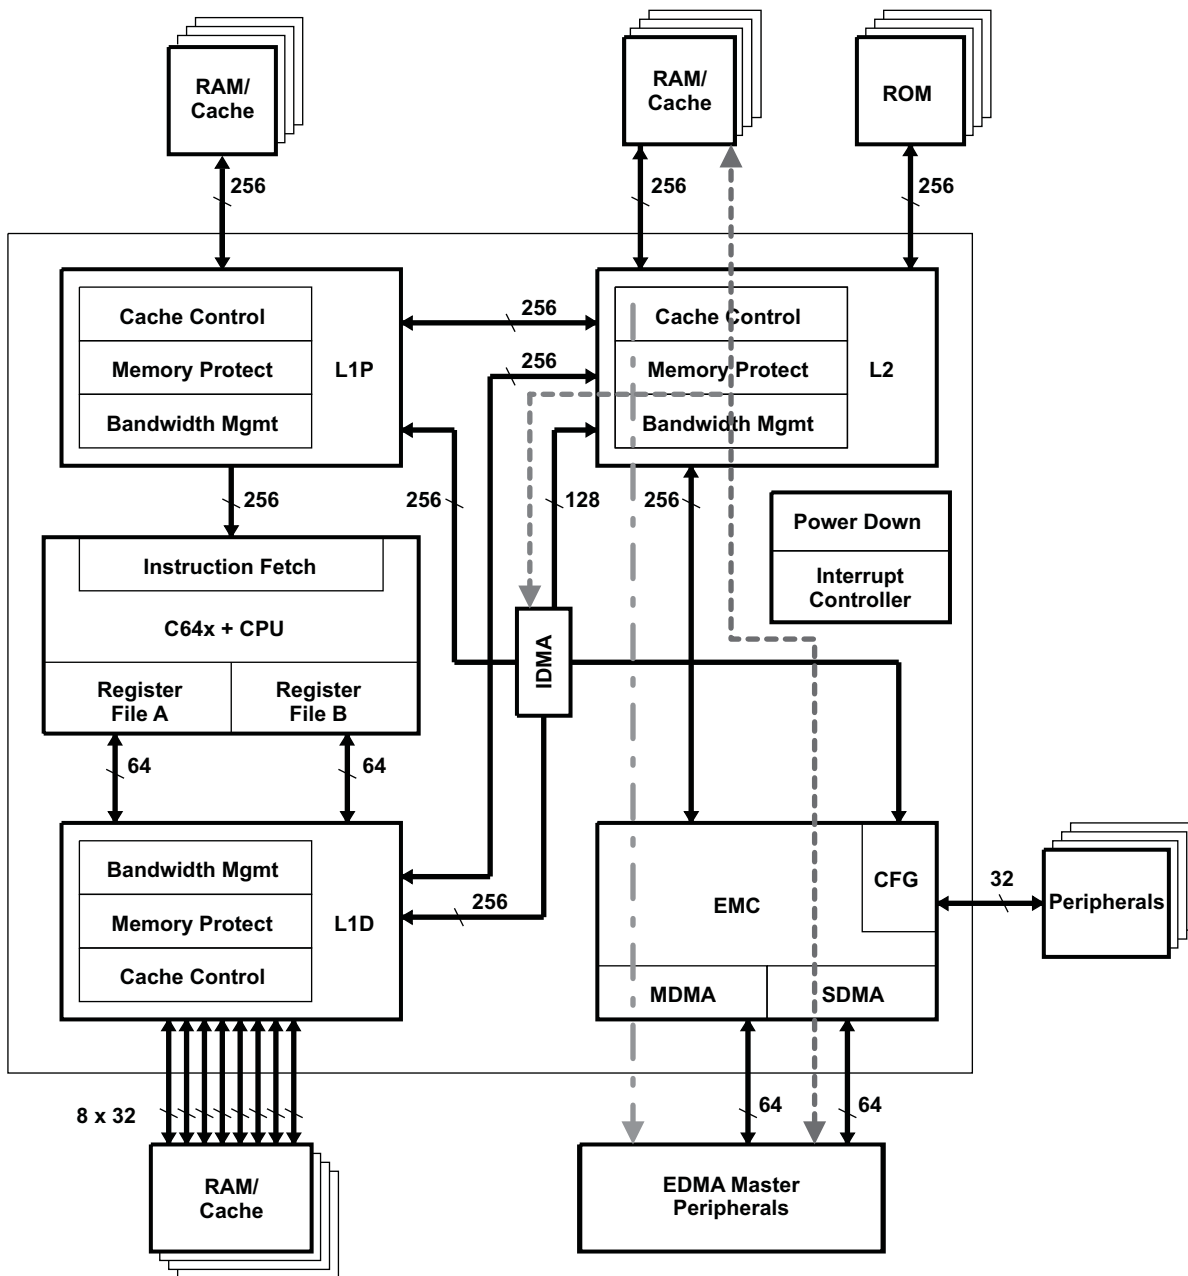
Figure 6. IDMA, SDMA, MDMA Paths

Ideally, the MDMA (dashed-dotted line in [Figure 6](#)) and SDMA/IDMA paths (dashed lines in [Figure 6](#)) operate independently with minimal interference. Normally MDMA accesses may stall for extended periods of time due to expected system level delays (e.g., bandwidth limitations, DDR2 memory refreshes). However, when using L2 as RAM, SDMA and IDMA accesses to L2/L1 may experience unexpected stalling in addition to the normal stalls seen by the MDMA interface. For latency-sensitive traffic, the SDMA stall can result in missing real-time deadlines. In a more severe case, the SDMA stall can produce a deadlock condition in the device. An IDMA stall cannot produce a deadlock condition.

**Note:** SDMA/IDMA accesses to L1P/D **will not** experience an unexpected stall if there are no SDMA/IDMA accesses to L2. Unexpected SDMA/IDMA stalls to L1 happen *only* when they are pipelined behind L2 accesses. Additionally, the deadlock scenario will be avoided if there are no SDMA accesses to L2.
