Errata

TMS320F2802x, TMS320F2802xx MCUs Silicon Revisions B, A, 0

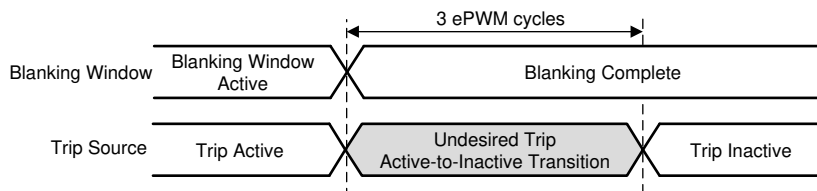
Figure 4-1. Undesired Trip Event and Blanking Window Expiration

Details The blanking window is typically used to mask any PWM trip events during transitions which would be false trips to the system. If an ePWM trip event remains active for less than three ePWM clocks after the end of the blanking window cycles, there can be an undesired glitch at the ePWM output.

Figure 4-1 illustrates the time period which could result in an undesired ePWM output.

Workaround(s) Extend or reduce the blanking window to avoid any undesired trip action.
