**AM5K2E04/02**  
**Multicore ARM KeyStone II SOC**  
**Silicon Revision 1.0**

# **Silicon Errata**

Literature Number: SPRZ416B  
May 2014–Revised August 2015

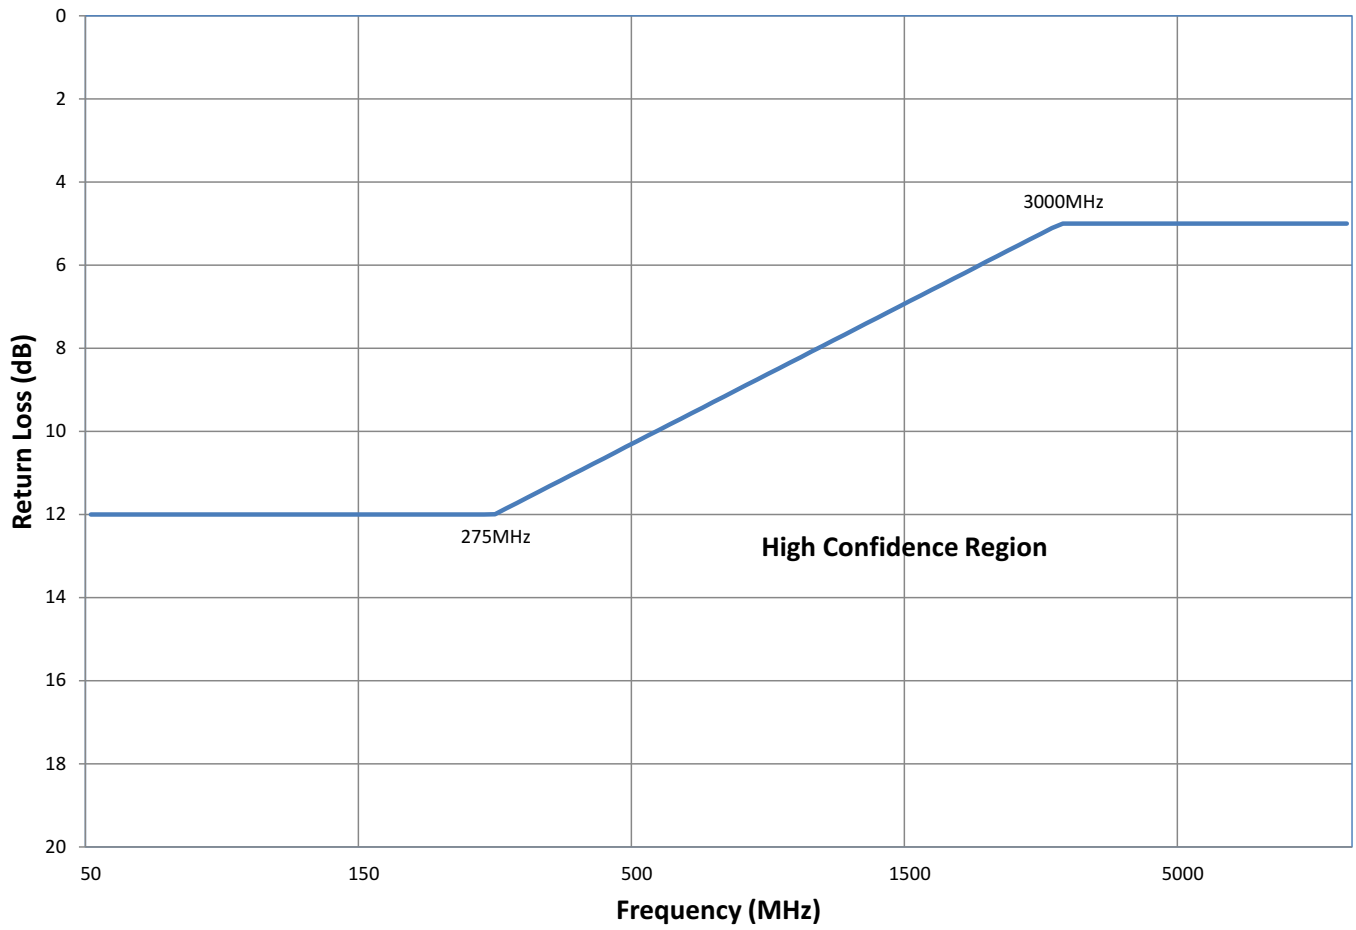
Characterization has shown that channels must also be compliant with the Return Loss template contained in the IEEE 802.3-2008 Annex 69B specification without modification. This is shown below for convenience.

**Workaround**      None.

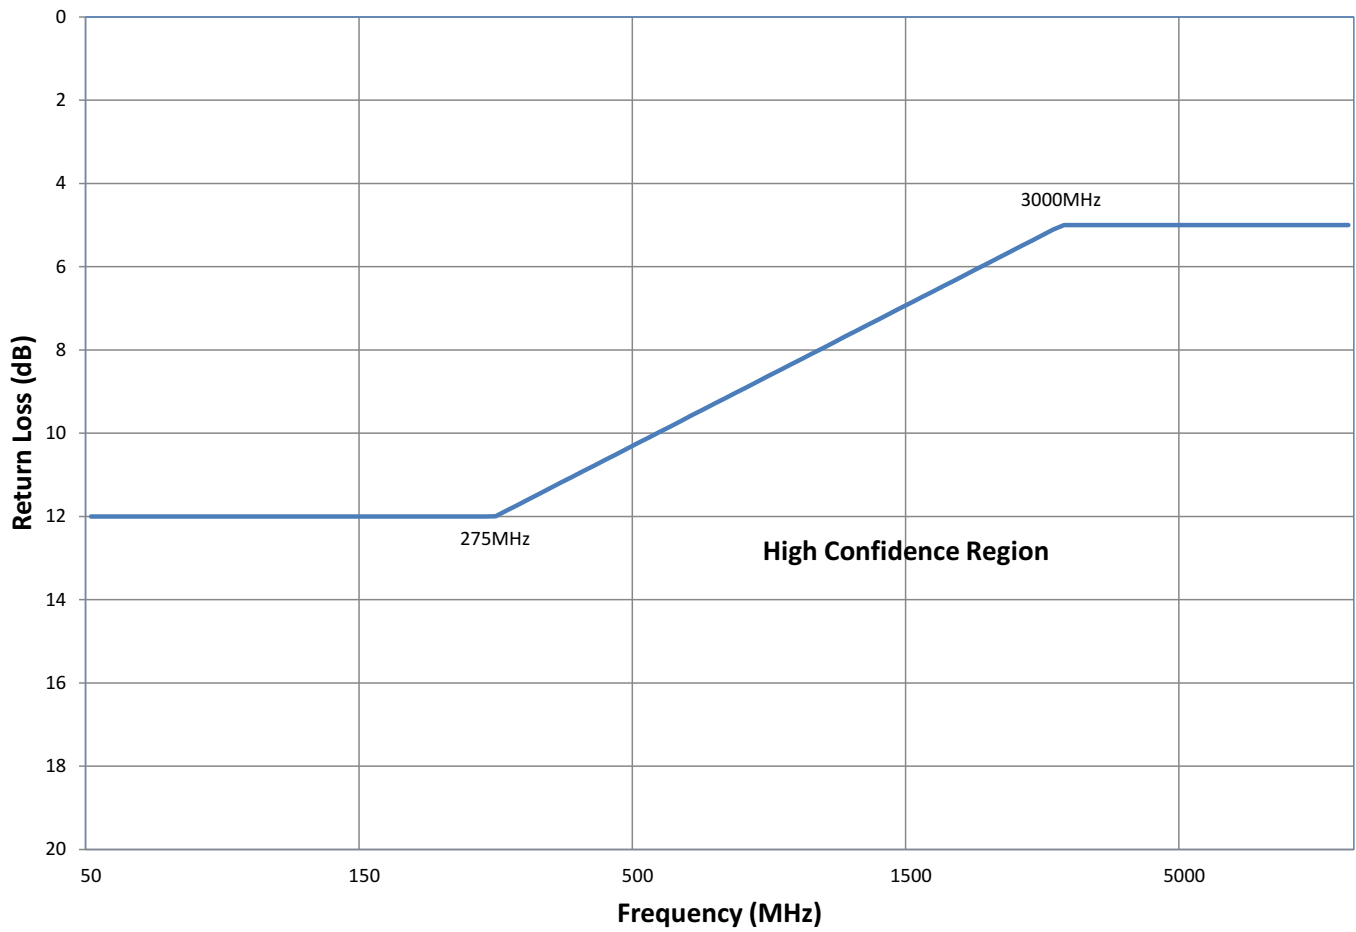
Device characterization has also shown that channels should be compliant with the Return Loss template shown below. The Return Loss measurement indicates the amount of energy reflected back to the source which is not available to the receiver. Impedance variation in the channel will cause reflected energy that can cause this template to be violated. Careful attention to PCB construction and layout must be followed to meet this requirement. This template must be met for the entire channel from transmitter to receiver including the series capacitors. Note that this is the same template

defined in IEEE 802.3-2008 Annex 69B specification for 10GbE.

**Workaround**      None.

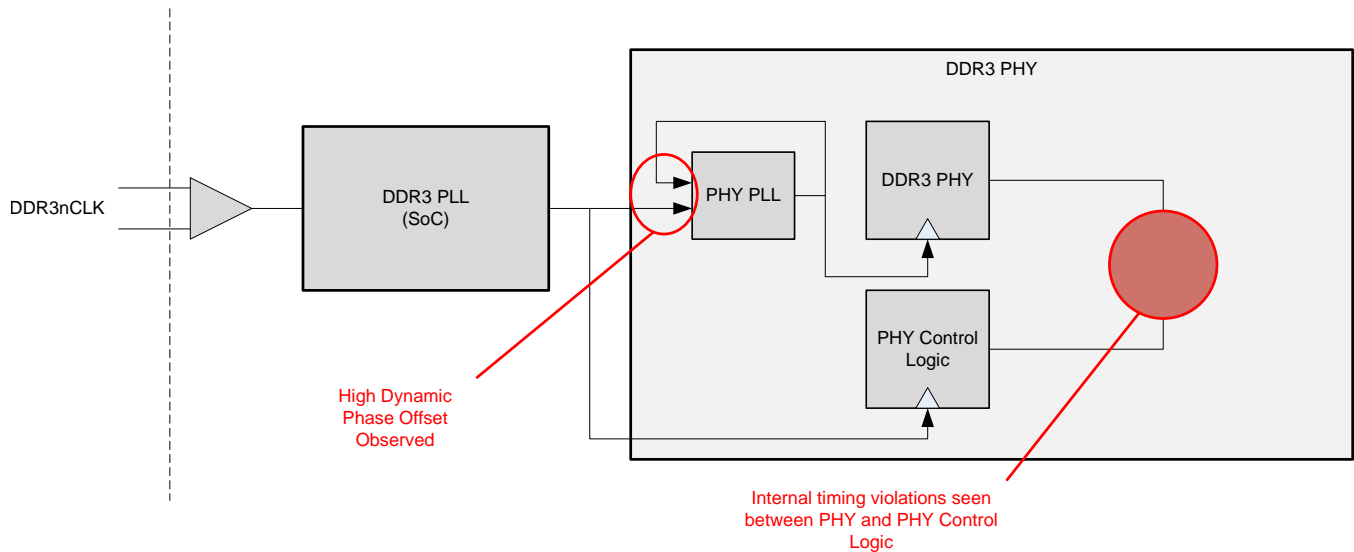
**Figure 2. DDR3 PHY**

DDR3 read operations may show errors due to increased levels of Dynamic Phase Offset (DPO) inside the DDR3 PHY. These errors are characterized by byte lane data corruption or intermittent bit errors. The byte lane data corruption can only be recovered using a device reset.

The DDR3 clocking architecture is illustrated in the figure below. The DDR3 reference clock input (DDR3nCLK) feeds the DDR3 SoC PLL, which outputs a clock to be used by the PHY Control Logic and provide an input to the PHY PLL.

The Dynamic Phase Offset (DPO) is a measure of the DDR3 PHY PLL’s ability to track rapid phase changes in the output of the DDR3 SoC PLL. High DPO can create internal timing violations between the DDR3 PHY and DDR3 PHY Control Logic and result in data errors during reads. As indicated by the shaded red circle in the figure above, the timing violations occur in the data transfer between the PHY and PHY control logic. It was determined that the root cause of the elevated DPO were SoC PLL and PHY PLL configurations that were non-optimized for the timing requirements of the system.

The workaround for this behavior is a change in the PLL configurations used for the DDR3 SoC PLL and the DDR3 PHY PLL. New configurations have been generated for DDR3-1600, DDR3-1333, DDR3-1066, and DDR3-800 operation and are presented in the tables below. Per field alert, "DDR3 Limited to Highest Data Rates Due to Possibility of PLL Instability During Temperature Changes after Startup", operation of DDR3-1066 and/or DDR3-800 is not recommended for affected Keystone2 devices in production systems

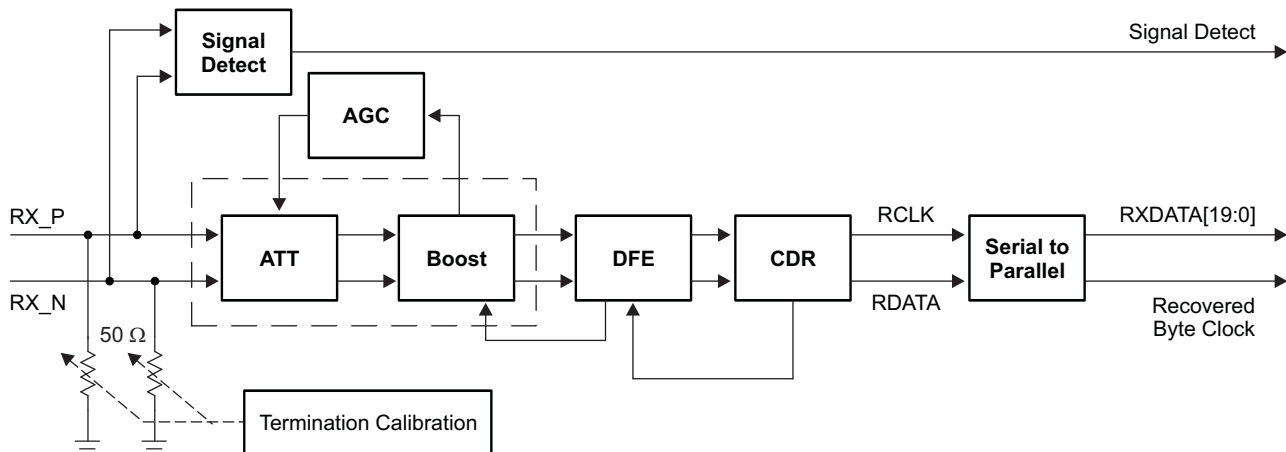
**Figure 3. RX Path Block Diagram**

**Problem Summary:** The SerDes on some peripherals will not automatically adapt its RX equalization when provided with certain data encodings common to that peripheral’s electrical standard.

**Details** The TI SerDes contains an adaptation algorithm that allows the RX equalization blocks to adapt their parameters to the SerDes data channel. The adaptation algorithm sets the optimal values for the ATT, BOOST, and DFE blocks in order to equalize the signal, maximize margin, and minimize channel distortion. For higher data rates (i.e. 5Gbps and greater), the high frequency gain provided by the BOOST block is generally considered necessary to compensate for the low-pass characteristics of data channels and widen the data eye.

The SerDes BOOST block was designed to require a specific set of patterns in order to best adapt its parameters to the channel. If these patterns are not found, the BOOST adaptation algorithm will not update the internal block settings and/or may incorrectly update these settings. The required data pattern is a series of six 0's followed by a 101 pattern. This pattern must occur numerous times on both odd and even bit alignments. This data pattern is not present in the 8b/10b coded symbols that are sent over many of the high speed peripheral links.

The recommended workaround is to not use the RX equalization auto-adaptation mechanism with the impacted interfaces at higher data rates. As an alternative, a user can hardcode the optimal ATT and BOOST values for their channel.

- Perform BER test with PRBS sequence and sweep across all values of ATT/BOOST while using a fixed set of TX parameters that have already been optimized. Use optimal ATT and BOOST value permutation that has the most margin. This is the value permutation that is both error-free and "farthest" from permutations with errors.
  - The SerDes DIAG tests can be found under `<TI_PDK_INSTALL_DIR>\packages\ti\diag\serdes_diag` in the latest CSL/PDK release and can be configured to perform this test.
- Perform a test where a PRBS data pattern is presented to the RX and the ATT/BOOST are allowed to auto-adapt. This method can also be used to identify the optimal ATT and BOOST value permutation that has the most margin.

The optimal ATT and BOOST values found by one of the two above methods can be hardcoded into the SerDes upon initialization.
