DRA75xP, DRA74xP, DRA77xP, DRA76xP SoC for Automotive Infotainment Silicon Revision 1.0

Errata

This document describes the known exceptions to the functional specifications for the device.

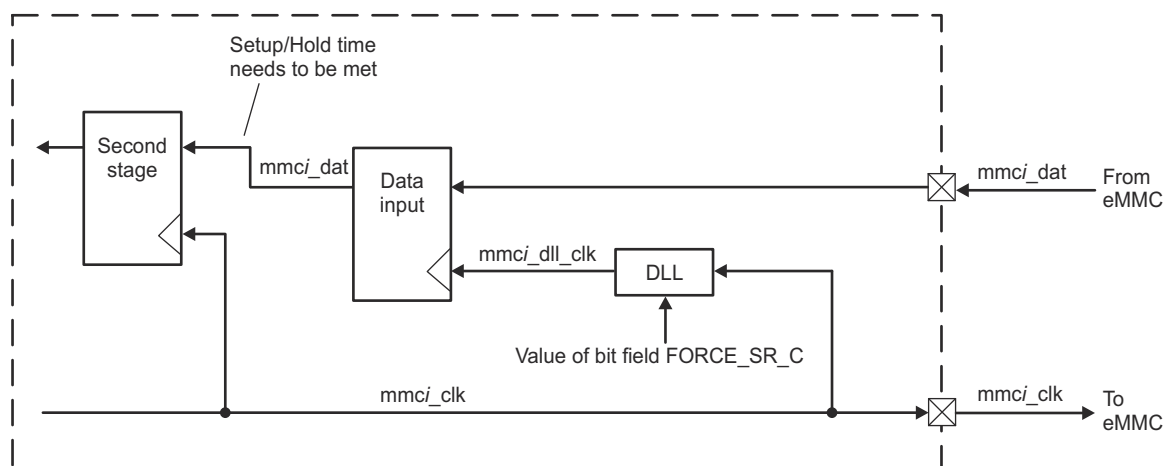
Figure 2-1. Simplified SoC 192-MHz Mode DLL Block Diagram

Internal to the MMC module, a second stage latch is used to recapture data captured by DLL delayed clock, `mmci_dll_clk`. The second stage latch captures with the original transmitting clock, `mmci_clk`.

`mmci_dll_clk` and `mmci_clk` both run at the same clock frequency. This results in a narrow range of tuning ratio elements, where the delayed `mmci_dll_clk` comes in phase with `mmci_clk`. If the clocks are in phase, the data captured by the first clock violates the setup and hold time requirements needed for the second stage latch, resulting in incorrectly read data. This is known as tuning re-timing errors.

A DLL tuning algorithm has been implemented that can avoid the tuning re-timing errors. More details on this can be found in App Note [SPRACA9](#). The following notes summarize the updated algorithm:
