# AM64x/AM243x Processor Silicon Revision 1.0, 2.0

## ABSTRACT

This document describes the known exceptions to the functional specifications (advisories). This document may also contain usage notes. Usage notes describe situations where the device's behavior may not match presumed or documented behavior. This may include behaviors that affect device performance or functional correctness.

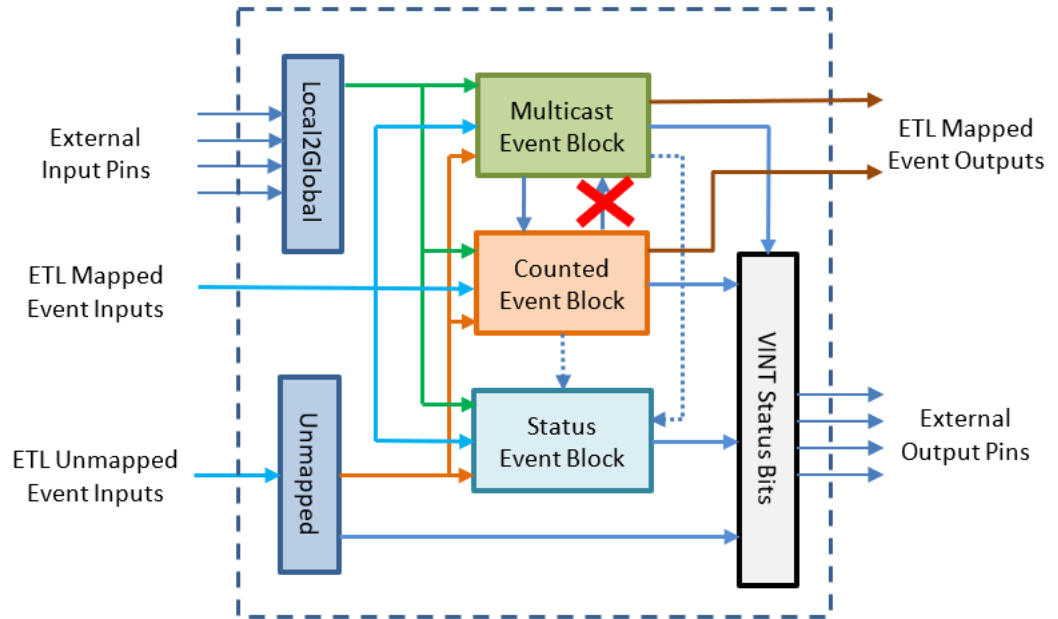
**Figure 2-2. Interrupt Aggregator Version 1.1**

IA version 1.1 introduced two additional changes to the architecture. First, there is a new processing block for “unmapped” events. These are events that are sent to a fixed destination (the IA) instead of being programmable at the source IP. Being fixed, they are called “unmapped”. Once in the IA, they are mapped to a traditional ETL event destination. The block that performs this mapping is called unmapped event block. The second change to the IA for 1.1 is that now, the multicast and counted event blocks (as well as the new unmapped event block) can directly set VINT status bits, and they do not need to forward output ETL events to the status event block.

By following the conventions outlined here, the system is safe from looping hazards that can create a deadlock scenario.

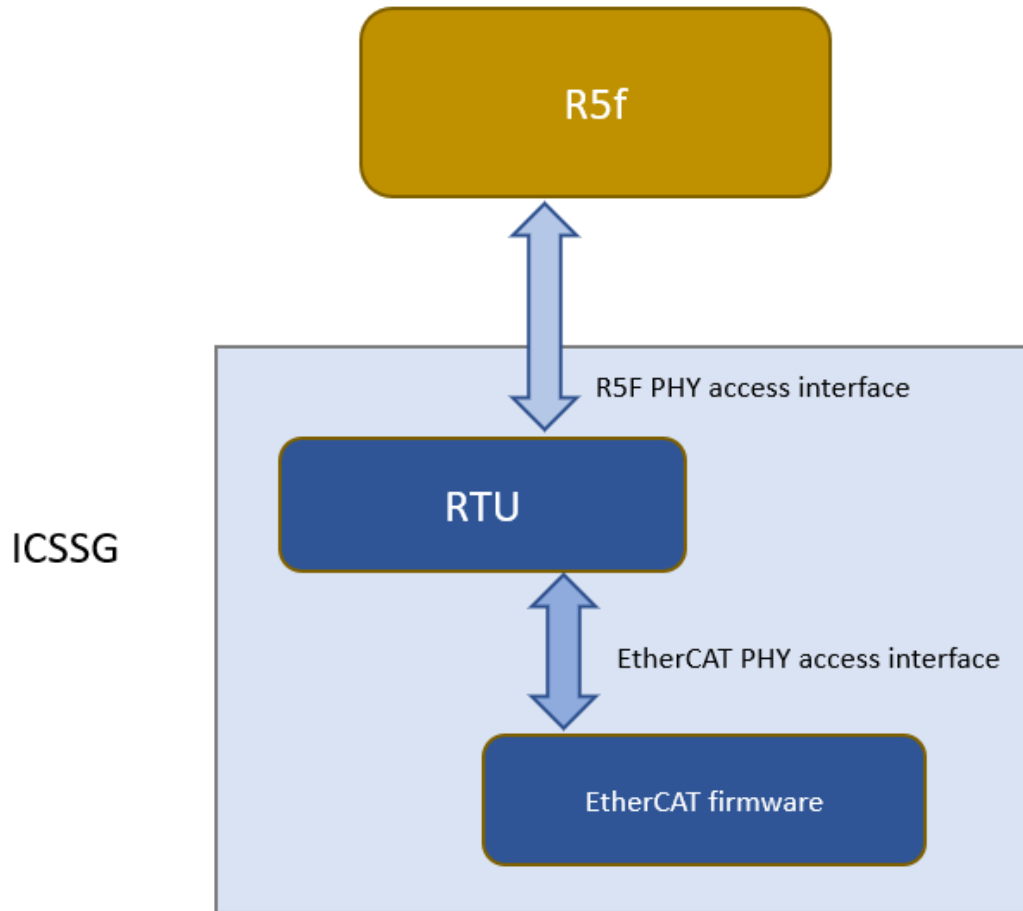
**Figure 2-3. MDIO Emulation via Manual Mode using PRU Core**

**i2329 (continued) MDIO: MDIO interface corruption (CPSW and PRU-ICSS)**
