ERRATA NOTES

CC113L

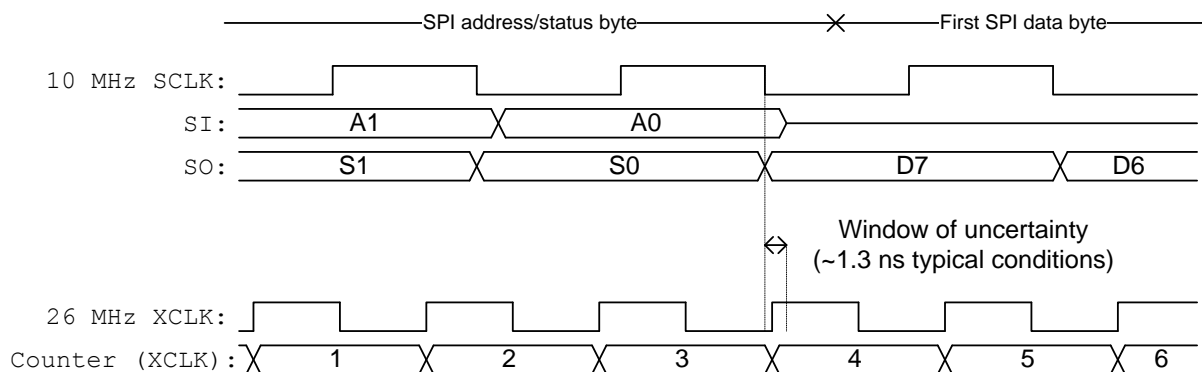
Figure 1: Window of Uncertainty (drawing not to scale)

Due to this synchronization issue, if the register being read changes value (synchronously with XCLK) during a certain period of time after this falling edge of SCLK then some of the bits in the read value will come from the previous value and some from the next value. This so-called window of uncertainty is about 1.3 ns for typical conditions and increases to about 2.0 ns for worst-case conditions (1.8 V VDD, 85 °C).

Figure 1 shows a timing diagram of an SPI read that fails when reading a fictitious counter being updated internally each XCLK. Since the counter update from value 3 (011b) to 4 (100b) within the window of uncertainty, the read value could be any one of 0-7 (000b, 001b, 010b, 011b, 100b, 101b, 110b, 111b) depending on exactly when the positive edge of XCLK falls within the window of uncertainty.

If it is important to **ensure** that read values are not corrupted, reading of one of the affected registers should be done repeatedly until the same value is read twice in succession. If the rate at which the register is read is specified to be at least twice as fast as the expected register update rate, then an upper bound on the number of required reads is four and the average number of reads slightly more than two.
