**IWR1443 Device Silicon Errata  
Silicon Revisions 1.0, 2.0, and 3.0**

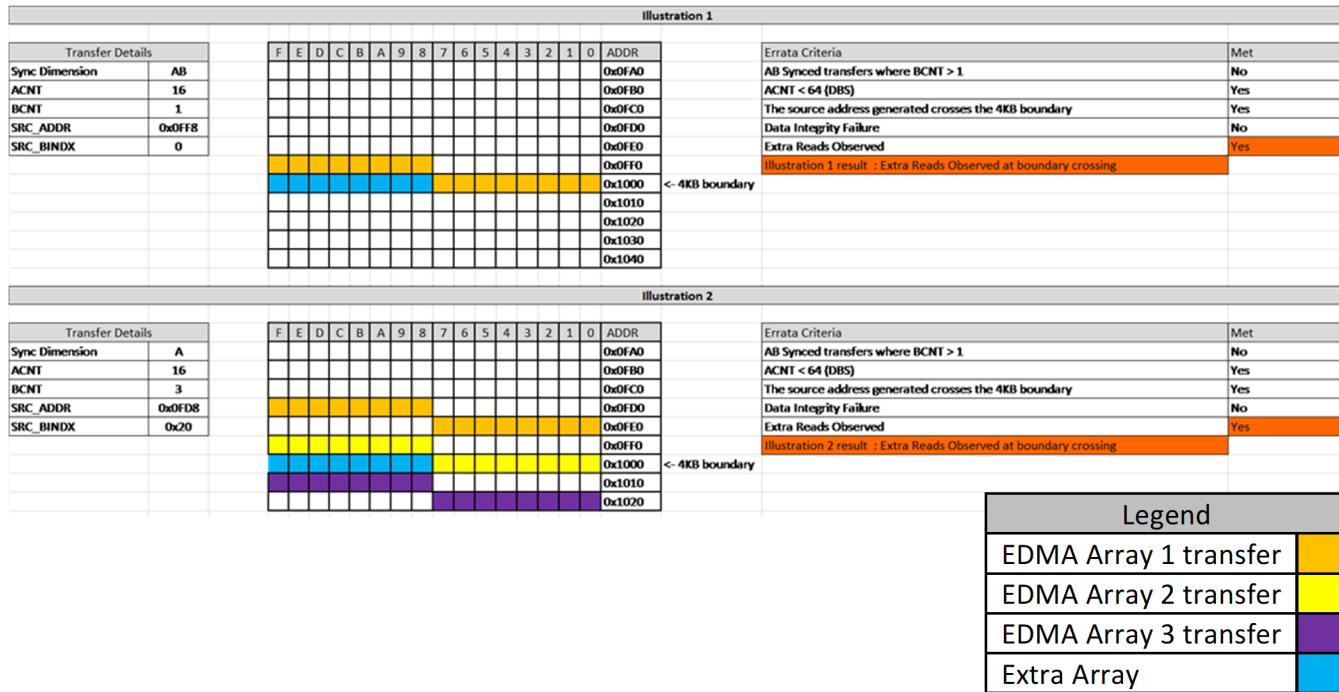
Figure 6-1. Scenario ID #3 – Extra Reads

For each extra read in **Scenario ID #3** for which [Condition \[1\]](#) is applicable, each index i above that satisfies the condition results in extra read from starting address SRC\_ADDR + (i + 1) \* SRCBIDX and of length equal to the distance from the start address to the boundary [that is, 0x1000 – X(i)]. Note: length < ACNT.

For **Scenario ID #3, Scenario ID #4, and Scenario ID #5**– EXTRA READS, another workaround besides avoiding the 4-KB boundary cross conditions, is to ensure that buffers involved in this kind of transfer are positioned so that extra reads stay within the physical memory boundaries. If the extra reads go to Reserved space or space blocked by the Memory Protection Unit (MPU), the TPTC generates a bus error interrupt to the processor.

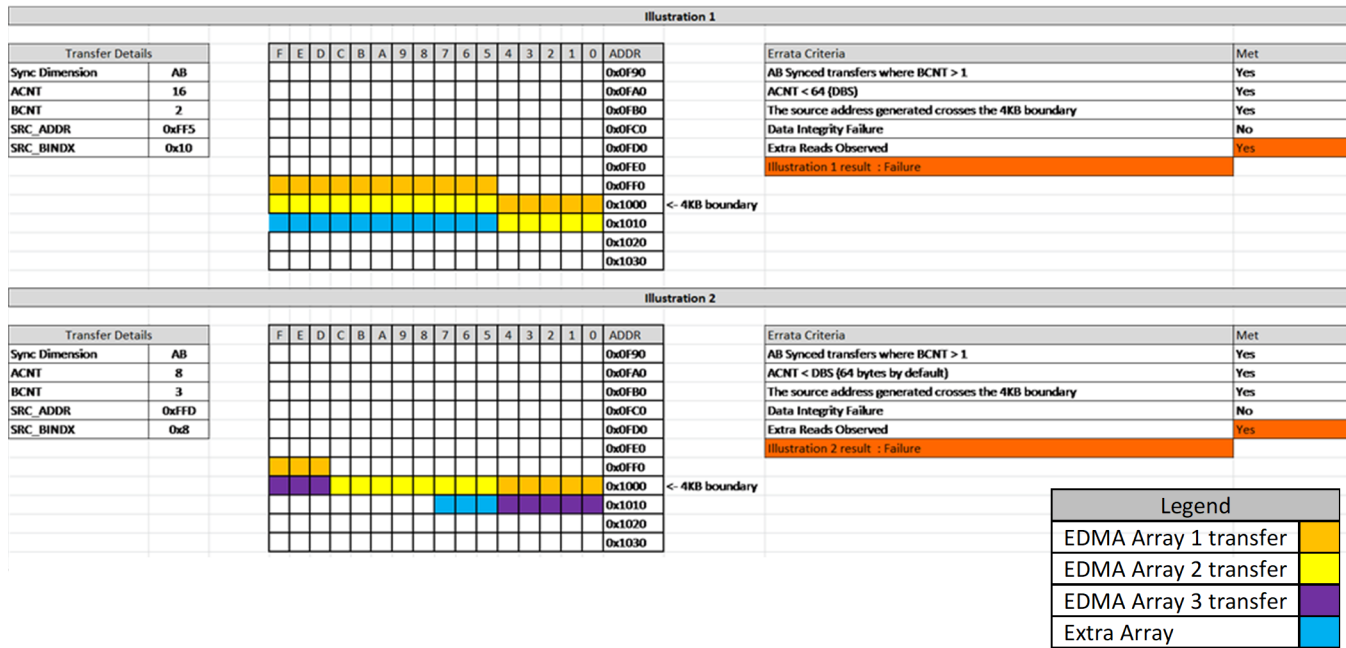
Figure 6-2. Scenario ID #4 – Extra Reads

For each extra read **Scenario ID #4** in for which **Condition [1]** is applicable, there is an extra read from starting address SRC + BCNT \* ACNT (=SRCBIDX) of length equal to the distance of the start address to the boundary [that is, length is 0x1000 – X(i)], where i is the index of one and only 4-KB boundary crossing condition. Note: length < ACNT.

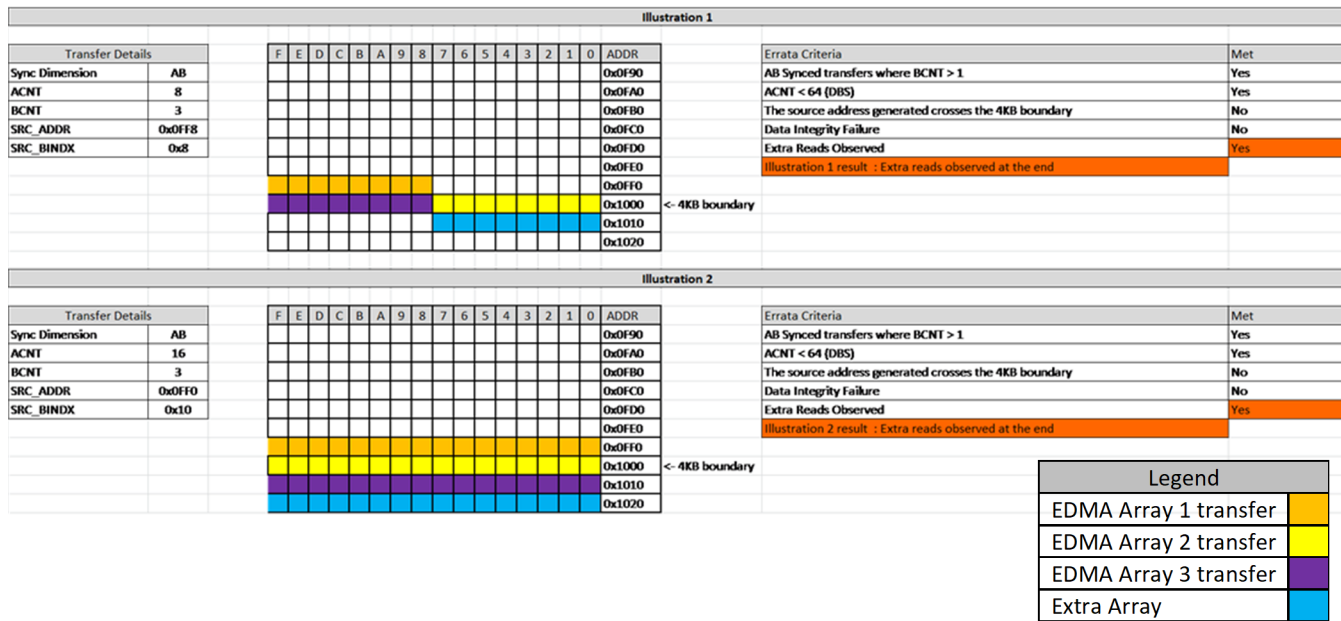
Figure 6-3. Scenario ID #5 – Extra Reads

For the extra read **Scenario ID #5** in for which **Condition [2]** is applicable, there is an extra read from starting address SRC + BCNT \* ACNT (=SRCBIDX) of length equal to the distance of the start address and is of length ACNT.
