## ABSTRACT

This document describes the known exceptions to the functional specifications (advisories).

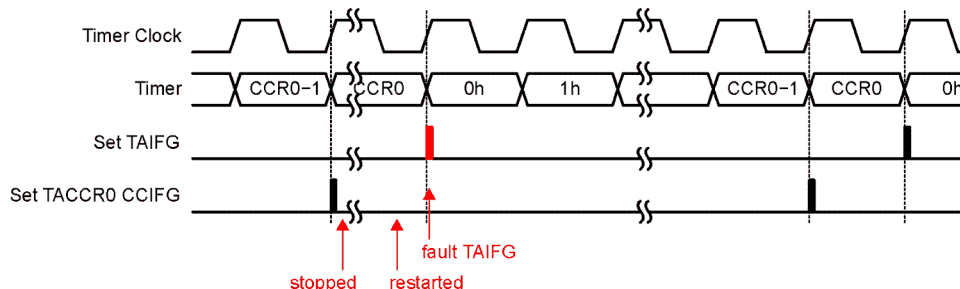
**TA21** *TA Module*

**Function** TAIFG Flag is erroneously set after Timer A restarts in Up Mode

**Description** In Up Mode, the TAIFG flag should only be set when the timer counts from TACCR0 to zero. However, if the Timer A is stopped at TAR = TACCR0, then cleared (TAR=0) by setting the TACLK bit, and finally restarted in Up Mode, the next rising edge of the TACLK will erroneously set the TAIFG flag.

**Workaround** None.

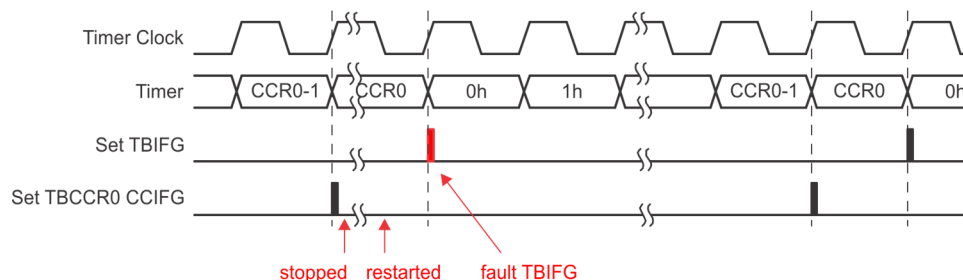
**Function** TBIFG Flag is erroneously set after Timer B restarts in Up Mode

**Description** In Up Mode, the TBIFG flag should only be set when the timer resets from TBCCR0 to zero. However, if the Timer B is stopped at TBR = TBCCR0, then cleared (TBR=0) by setting the TBCLR bit, and finally restarted in Up Mode, the next rising edge of the TBCLK will erroneously set the TBIFG flag.

**Workaround** None.
