Errata  
**MSP430F2012 Microcontroller**

This document describes the known exceptions to the functional specifications (advisories).

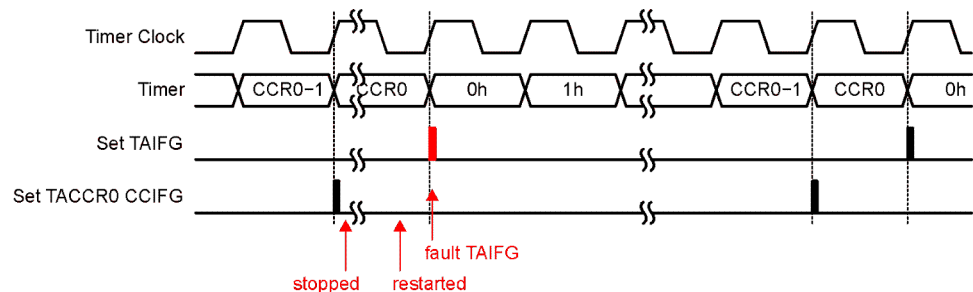
**TA21**
**TA Module**
**Category**

TAIFG Flag is erroneously set after Timer A restarts in Up Mode

In Up Mode, the TAIFG flag should only be set when the timer counts from TACCR0 to zero. However, if the Timer A is stopped at TAR = TACCR0, then cleared (TAR=0) by setting the TACLK bit, and finally restarted in Up Mode, the next rising edge of the TACLK will erroneously set the TAIFG flag.

None.
