## ABSTRACT

This document describes the known exceptions to the functional specifications (advisories).

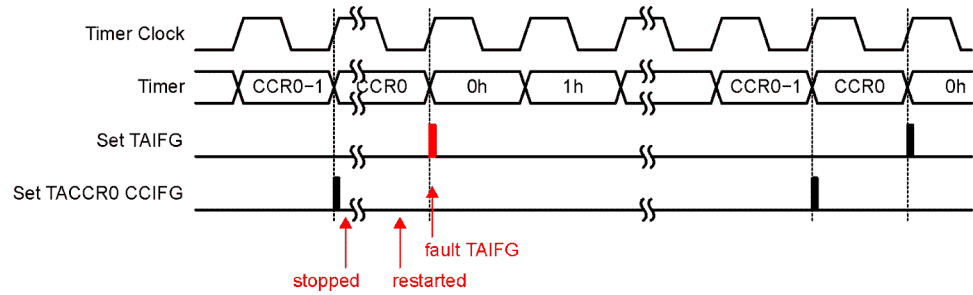
**Function** TAIFG Flag is erroneously set after Timer A restarts in Up Mode

**Description** In Up Mode, the TAIFG flag should only be set when the timer counts from TACCR0 to zero. However, if the Timer A is stopped at TAR = TACCR0, then cleared (TAR=0) by setting the TACLR bit, and finally restarted in Up Mode, the next rising edge of the TACLK will erroneously set the TAIFG flag.

**Workaround** None.

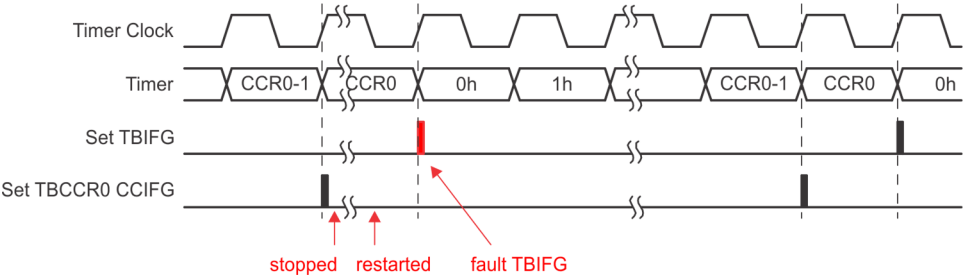
| <b>Function</b> | TBIFG Flag is erroneously set after Timer B restarts in Up Mode |
| <b>Description</b> | In Up Mode, the TBIFG flag should only be set when the timer resets from TBCCR0 to zero. However, if the Timer B is stopped at TBR = TBCCR0, then cleared (TBR=0) by setting the TBCLR bit, and finally restarted in Up Mode, the next rising edge of the TBCLK will erroneously set the TBIFG flag. |

| <b>Workaround</b> | None. |
