## ABSTRACT

This document describes the known exceptions to the functional specifications (advisories).

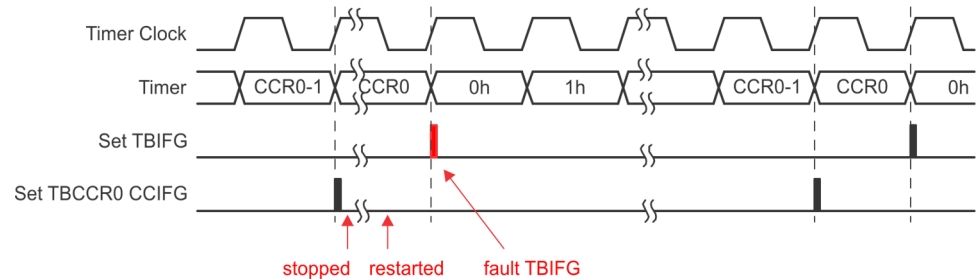
**Function** TBIFG Flag is erroneously set after Timer B restarts in Up Mode

**Description** In Up Mode, the TBIFG flag should only be set when the timer resets from TBCCR0 to zero. However, if the Timer B is stopped at TBR = TBCCR0, then cleared (TBR=0) by setting the TBCLR bit, and finally restarted in Up Mode, the next rising edge of the TBCLK will erroneously set the TBIFG flag.

**Workaround** None.
