ABSTRACT

This document describes the known exceptions to the functional specifications (advisories).

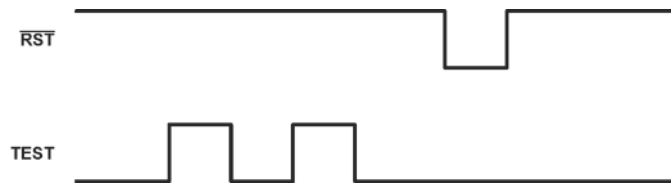
Note: This toggling of TEST pins is not subject to timing constraints. The appropriate level transitions on TEST pin, followed by a RST pulse after 50us, are sufficient to trigger an exit from BSL mode.

- Toggle the TEST pin twice when nRST is high and after 50us pull nRST low.

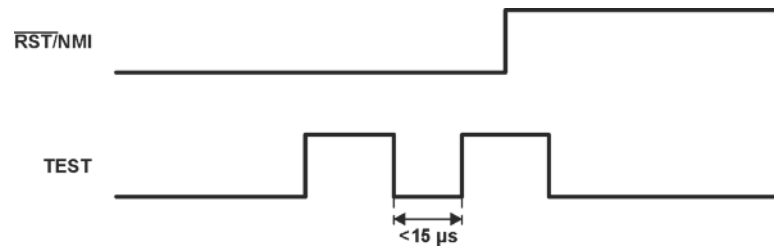
SYS10 *SYS Module*

Category	Functional
Function	BSL entry sequence is subject to specific timing requirements
Description	The BSL entry sequence requires that the low phase of the TEST/SBWTCK pin does not exceed 15us. This timing requirement is faster than most PC serial ports can provide, as shown in the following picture. If this requirement is not met, the entry sequence fails and the SYSBSLIND is not set.

Workaround An external hardware solution is recommended to provide the appropriate BSL entry sequence. See [http://processors.wiki.ti.com/index.php/BSL_\(MSP430\)](http://processors.wiki.ti.com/index.php/BSL_(MSP430)) for recommendations on available BSL hardware.
