ABSTRACT

This document describes the known exceptions to the functional specifications (advisories).

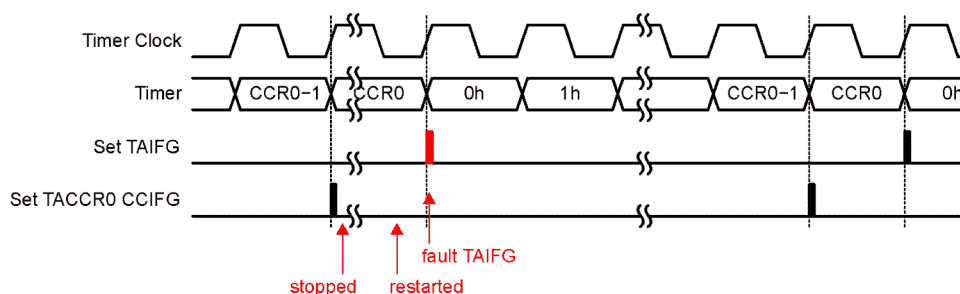
TA21 *TA Module*

Function TAIFG Flag is erroneously set after Timer A restarts in Up Mode

Description In Up Mode, the TAIFG flag should only be set when the timer counts from TACCR0 to zero. However, if the Timer A is stopped at TAR = TACCR0, then cleared (TAR=0) by setting the TACLK bit, and finally restarted in Up Mode, the next rising edge of the TACLK will erroneously set the TAIFG flag.

Workaround None.

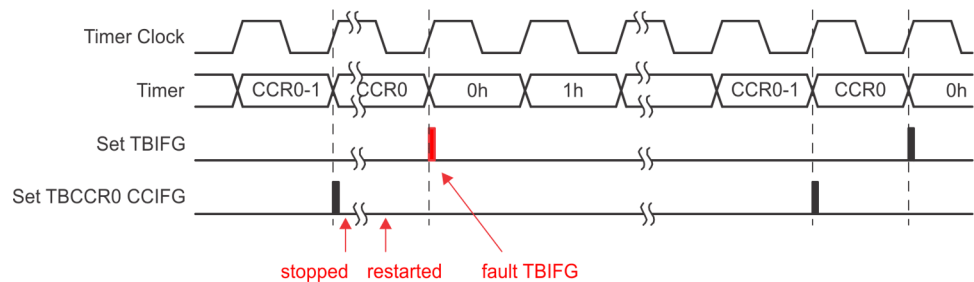
TB24

TBIFG Flag is erroneously set after Timer B restarts in Up Mode

In Up Mode, the TBIFG flag should only be set when the timer resets from TBCCR0 to zero. However, if the Timer B is stopped at TBR = TBCCR0, then cleared (TBR=0) by setting the TBCLR bit, and finally restarted in Up Mode, the next rising edge of the TBCLK will erroneously set the TBIFG flag.

None.
