MSP430FW425 Device Erratasheet

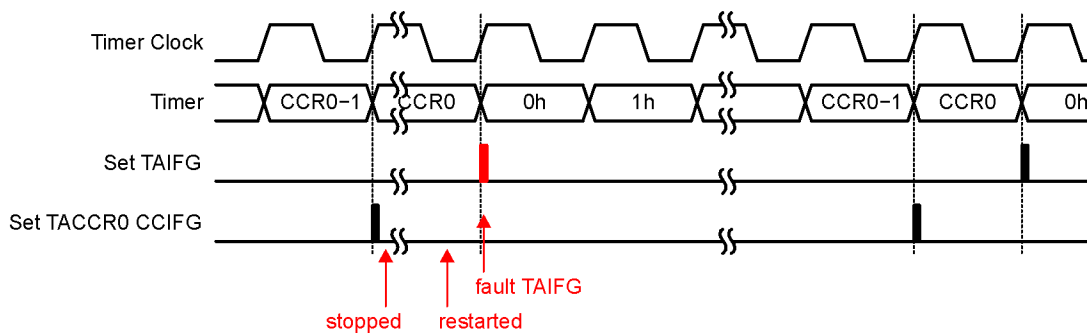
TA21 *TIMER_A Module*

Function TAIFG Flag is erroneously set after Timer A restarts in Up Mode

Description In Up Mode, the TAIFG flag should only be set when the timer counts from TACCR0 to zero. However, if the Timer A is stopped at TAR = TACCR0, then cleared (TAR=0) by setting the TACLK bit, and finally restarted in Up Mode, the next rising edge of the TACLK will erroneously set the TAIFG flag.

Workaround None.
