TMS320C6712, TMS320C6712C, TMS320C6712D
Digital Signal Processors
Silicon Errata

C6712 Silicon Revisions 1.0, 1.2, 1.3

C6712C Silicon Revision 1.1

SPRZ1820
May 2001
Revised August 2005

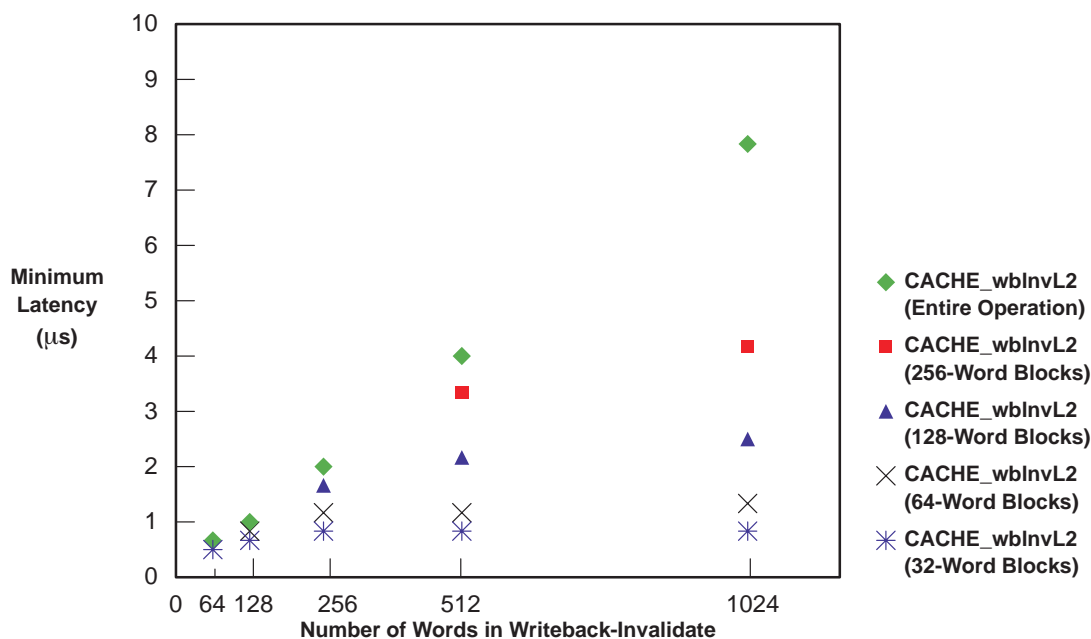
Figure 2. Minimum Required Latency Between McBSP Events for a Successful Transfer with Concurrent L2 Writeback-Invalidates at 200-MHz CPU and 50-MHz EMIF, Using Entire Operations and Block Breakdown

For example, if the CPU is running at 200 MHz with a 50-MHz EMIF and you have a McBSP hard real-time deadline of 5 μ s, Figure 2 shows that a 1024-word L2 writeback-invalidate may cause data loss since back-to-back McBSP events can only be serviced at ~ 8 μ s. By breaking down the L2 writeback-invalidate into 256-word blocks, you can then meet the 5- μ s McBSP deadline. In other words, when performing a 1024-word L2 writeback-invalidate operation with the CPU and EMIF conditions cited above, the McBSP events can be serviced in ~ 8 μ s for the entire operation (one whole block), in ~ 4 μ s when breaking it into 256-word blocks, in ~ 2.5 μ s when breaking it into 128-word blocks, etc.

To avoid cache operations blocking other time-sensitive EDMA accesses, observe the following guidelines:

1. Avoid placing real-time data in EMIF address range. Instead, real-time data should be placed in the L2 address range.
2. If data must be placed in the EMIF address range:
 - Avoid global cache operations in favor of block-based cache operations.
 - Block-based cache operations should be submitted in small blocks, such that the total amount of time that the EMIF is blocked is less than the amount of time between serial samples.

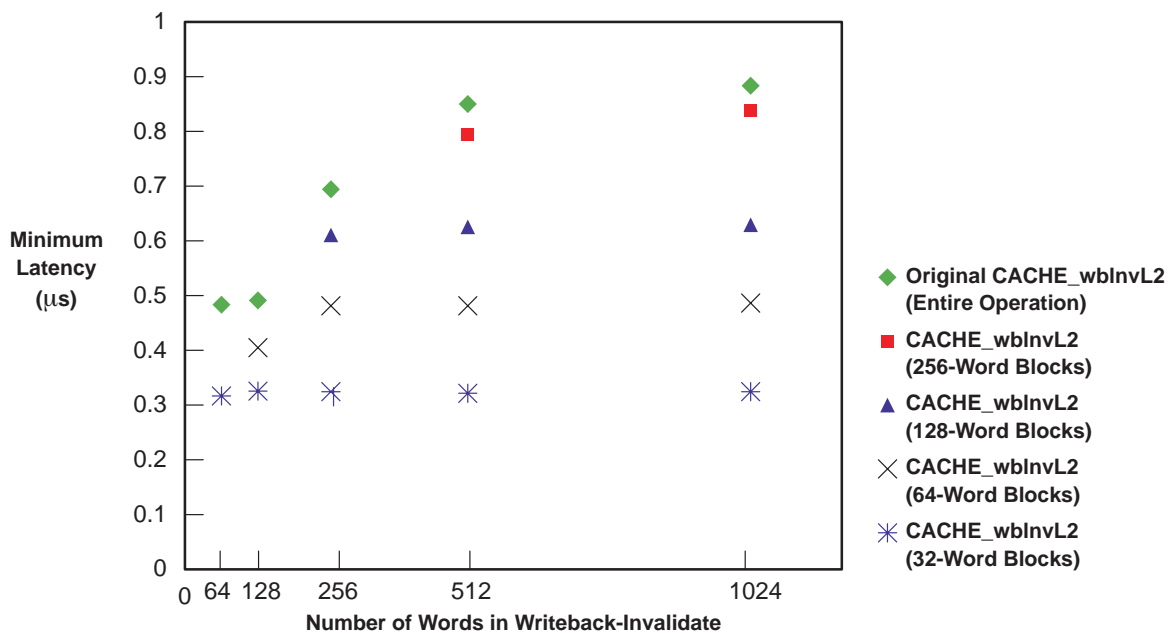
Figure 3. Minimum Required Latency Between McBSP Events for a Successful Transfer With Concurrent Writeback-Invalidates at 225-MHz CPU and 100-MHz EMIF, Using Entire Operations and Block Breakdown

When the CPU is set to 225 MHz and the EMIF is set to 100 MHz, breaking down the cache operations will still improve the block-out problem. Figure 3 shows the improvement in the McBSP's performance with this frequency ratio.

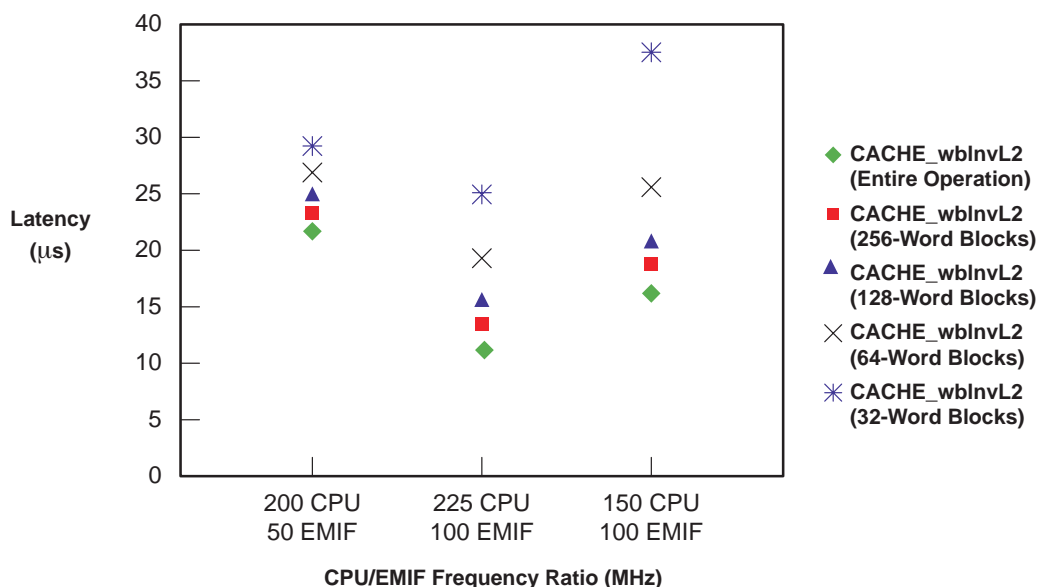
Figure 5. 1024-Word L2 Writeback-Invalidate Performance at Various Frequency Ratios With Old and New CACHE-wbInvL2()

Breaking down the cache operations into smaller blocks takes longer to complete than performing the entire cache function as one large block. Figure 5 shows how much extra overhead is incurred by breaking down an L2 writeback-invalidate operation to transfer 1024 words with different sized blocks and at various frequency ratios. Notice that for the 200-MHz CPU and the 50-MHz EMIF frequency ratio, where the new functions are most critical for peripherals such as the McBSP, the least overhead is incurred.

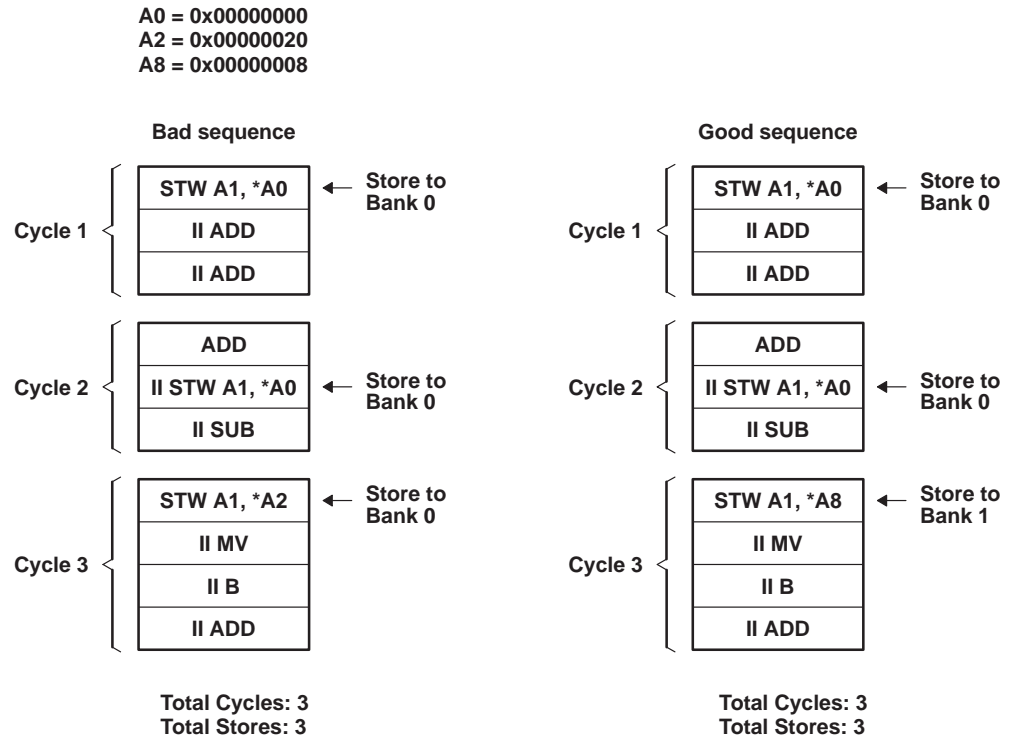
Figure 8. Pseudo Code Example Stores to Specified Banks (Criteria 3)

- All stores in the loop must be to the same bank of L2. If there are any stores to another bank, this will free the first bank long enough for the EDMA access to get in (see Figure 8).

In the case of two stores occurring on the same cycle, in parallel, the same rules apply. If both stores are to the same bank (and there are no other stores in the sequence to a different bank), then a problem may occur. If each of the parallel stores is to a different bank, then the problem cannot occur.

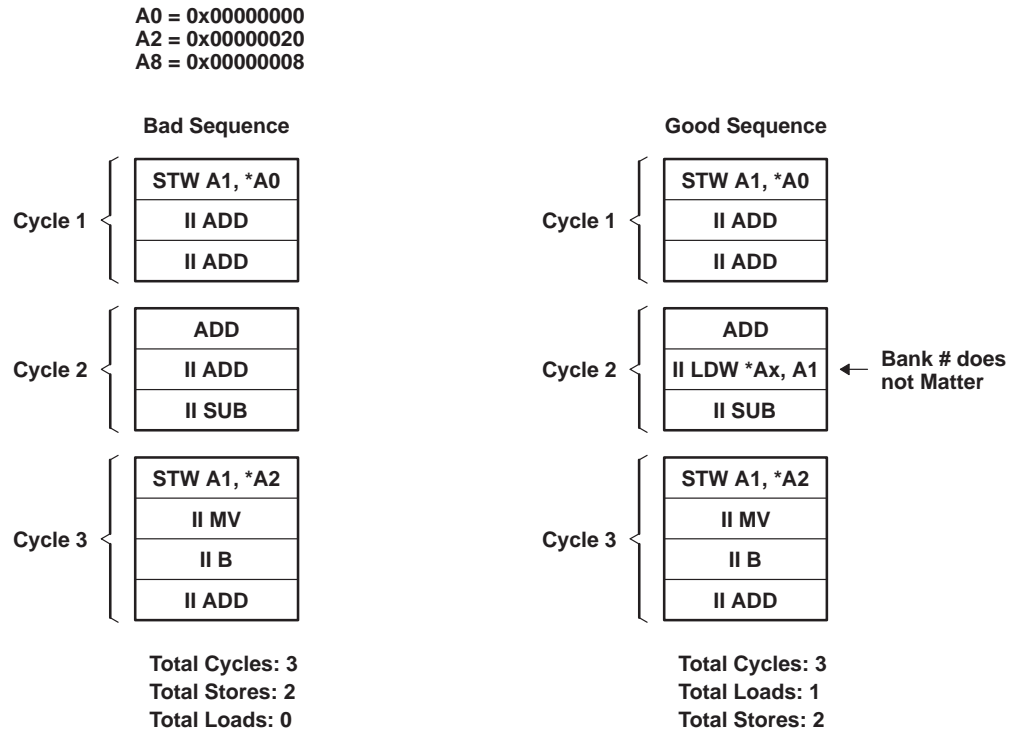
Figure 9. Pseudo Code Example Stores and Loads (Criteria 4)

A load from L2 provides enough of a gap to allow the EDMA to access L2. The good sequence would not cause a problem even if the load were executed in parallel with one of the stores, as long as the load occurred somewhere in the sequence. Notice that although the good sequence satisfies criteria 2 and 3, it would not cause a problem.

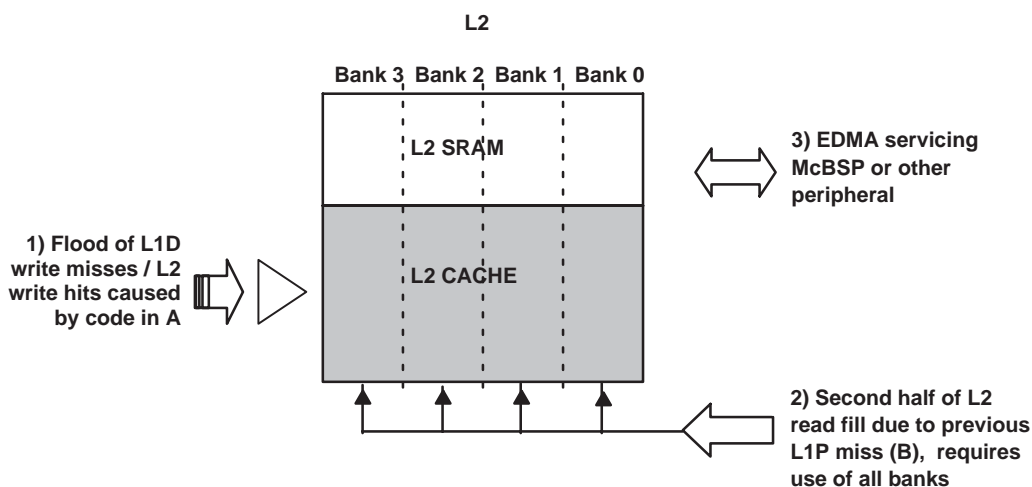
Figure 10. Problem Scenario

In this scenario, the next CPU fetch packet does not reside in either L1P or L2 cache; therefore, it causes an L1P and L2 miss. An L2 cache line (128 bytes, 4 fetch packets) must be fetched from external memory. The fetch from external memory is split into two requests (two halves) of 64 bytes, or two fetch packets each. In this document, the two halves are labeled A and B, respectively, as shown in Figure 10. The first half (A) to arrive in L2 is the half in which the missed fetch packet resides. This first half is immediately forwarded to L1P so that CPU can resume execution before the second half (B) is fetched from external memory. The second half of the L2 line (B) is to be fetched and written to L2 later.

The lockout condition occurs only when the second half (B) of the L2 cache line fill starts. When the B is ready, it attempts to write to L2. It will be unable to do so, however, because the line fill operation accesses all four banks of L2 whereas one bank is always busy servicing the higher priority L1D misses from the code in A. Thus, the line fill (B) cannot complete until the flood of writes from A has stopped. The line fill stays at the head of queue in the EDMA controller, so any other EDMA transfers that access L2 will also be blocked until the flood of stores has stopped *and* the L2 line fill (B) has completed.

The amount of time that an EDMA transfer is locked out of L2 is determined by the code running on the DSP (A), and ultimately by the amount of time that L1D write misses are happening in succession. When all of the conditions are met, the second half of the L2 line fill and the EDMA will be locked out of L2 as long as the flood of stores is sustained.

- Avoid the flood of L1D write misses. Pre-read all data locations prior to writing them. This will allocate them in L1D, preventing the L1D write misses from occurring. Recall that L1D read misses do not cause problems.
- Make sure that any algorithm or code segment that naturally produces a long string of writes inserts gaps in the write sequence such that writes occur at a frequency slower than 1 write miss every other cycle. The term "long" is based on the system requirements. Gaps in the L1D write misses means that the second half of the L2 read fill is given a chance to access L2.

- Run the algorithm or code segment that contains A from internal SRAM. There will not be L2 code read fill (A or B) coming into L2. The simulator can be used to detect such code segment. See the C6x1x Simulator section below for details.
- Ensure the problematic segment of algorithm or code is in cache. This can be accomplished by issuing any CPU read/load instruction from the beginning of the problematic code segment in external memory, that will cause both L1D and L2 miss. Assuming the code segment is not yet in L1/L2 cache, Performing CPU load instruction generates an L1D request, and CPU stalls until the code missed and data is returned from L2. After the load instruction, code segment will reside in the L2 cache, and an L2 read fill due to L1P miss will not occur.
