TMS320C6748 Fixed- and Floating-Point DSP Silicon Revisions 2.3, 2.1, 2.0, 1.1 and 1.0

Silicon Errata

Literature Number: SPRZ303H
June 2009–Revised March 2014

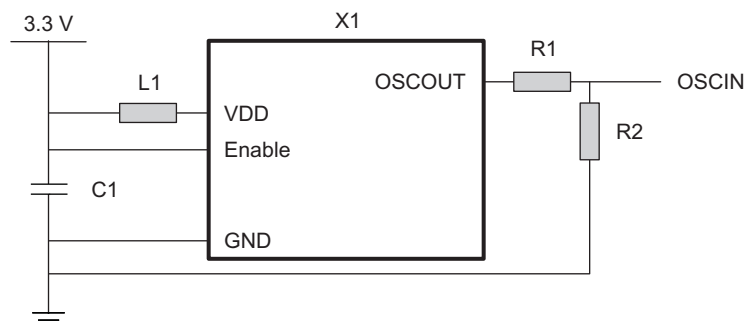
Figure 2. External 3.3V Clock Source

On all silicon revisions, certain design elements make this device susceptible to radiated noise during an ESD strike, as described in the standard IEC 61000-4-2. Exposure to the electrical noise caused by the ESD can cause soft device failures due to noise coupling on the system clock (OSCIN). ESD events within the IEC spec range do not cause permanent device damage and full functionality is recoverable with a device reset. The sensitivity to this noise issue is primarily due to the 1.2V oscillator/clock input implemented on this device. The low voltage range, coupled with slow rise and fall times, provides a lower noise margin than other TI devices with higher voltage internal oscillators (for example, 1.8V or 3.3V oscillators).

If ESD robustness is a concern, it is strongly recommended to avoid using the internal oscillator as a clock source. An external 3.3V clock source with a resistor voltage divider as in [Figure 2](#) can be used to externally generate the required 1.2V input clock. By using an external clock input with fast rise/fall times (less than 5 ns), the noise margin improves significantly, increasing ESD noise resistance.

Legend: L1 = ferrite bead; C1 = 0.1 uF; R1 = 165 ohm / 5%; R2 = 100 ohm / 5%

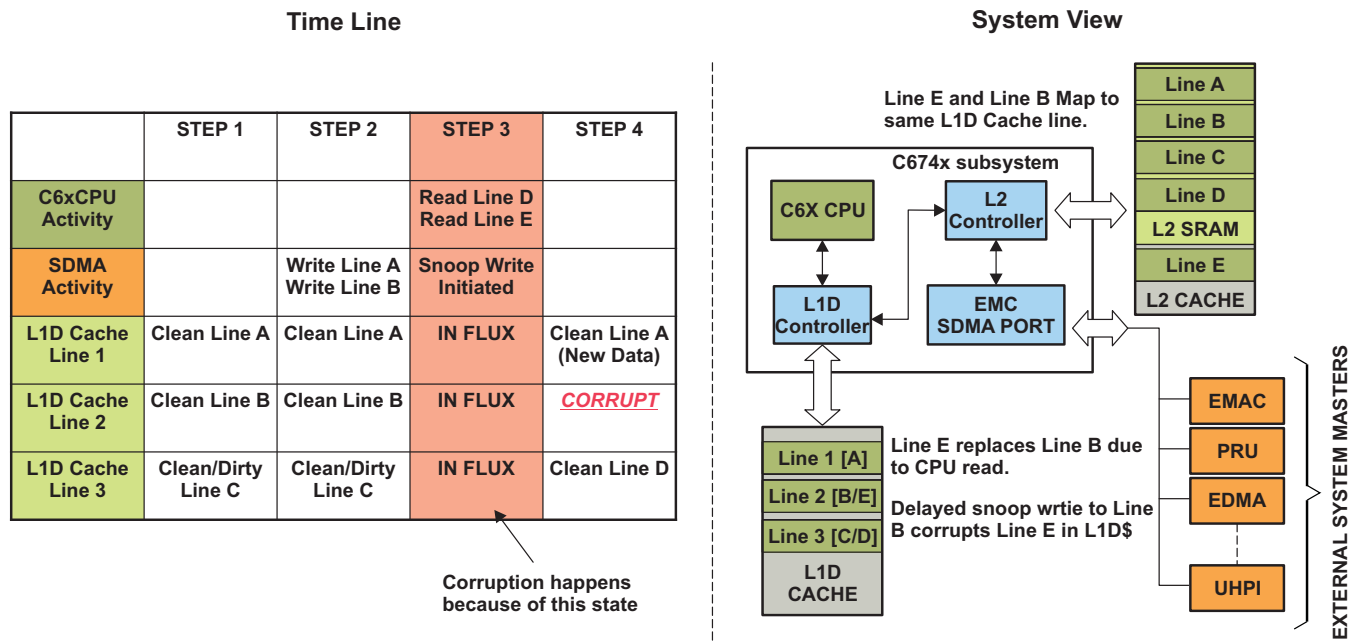
Figure 4. Example of L1D Cache Corruption
Workaround(s)

An L1D cache-line corruption event occurs when all of the conditions in the following steps are met (see [Figure 4](#)):

- Line E in L2 cache is read as a cache hit. Line E is destined to replace Line 2 in L1D Cache, which also has a snoop write pending for the updated Line B content.

- Line D in L2 SRAM is read. Line D will replace Line 3 in L1D cache.
4. When the snoop write operation completes, Line 2 in L1D cache now contains the updated L2 SRAM Line B data instead of the L2 cache Line E data.

The correct behavior would have been to kill the pending snoop write initiated to update L1D cache Line 2 with the updated L2 SRAM Line B data in Step 3. The L1D cache should have evicted Line B and replaced it with Line E data. Instead, the snoop write operation continues and does not complete until after the L1D cache Line 2 has already been replaced with L2 cache Line E data. The snoop write instruction overwrites the L1D cache Line 2 (containing L2 cache Line E data) with the updated L2 SRAM Line B data.

Method 1: Do not perform two CPU read operations in the same clock cycle. For C code, use compiler flag (**--c64p_dma_l1d_workaround**) available in the C6000 Compiler (CodeGen) Tools version 7.0.2 and later. For assembly code, the **--c64p_dma_l1d_workaround** flag will only issue a warning.

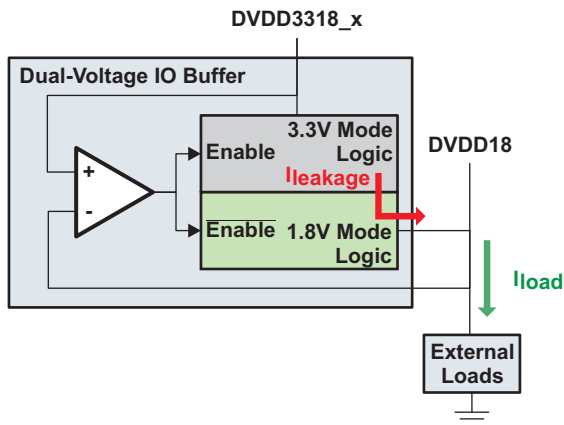
Figure 8. Error State of the IO buffer during Zone G

Error State of the IO buffer during Zone G:

As DVDD3318_x exceeds DVDD18+V_T, some of the circuitry across the boundary of the two voltage domains will turn on and causes a leakage current (in red) to flow between the two voltage domains. This current pulls up the DVDD18 supply unless the power source providing that supply can oppose it or unless the load current is strong enough to counteract it.

If DVDD18 continues to rise as DVDD3318_x ramps, the comparator never sees enough difference between the two supplies to switch to 3.3V mode.

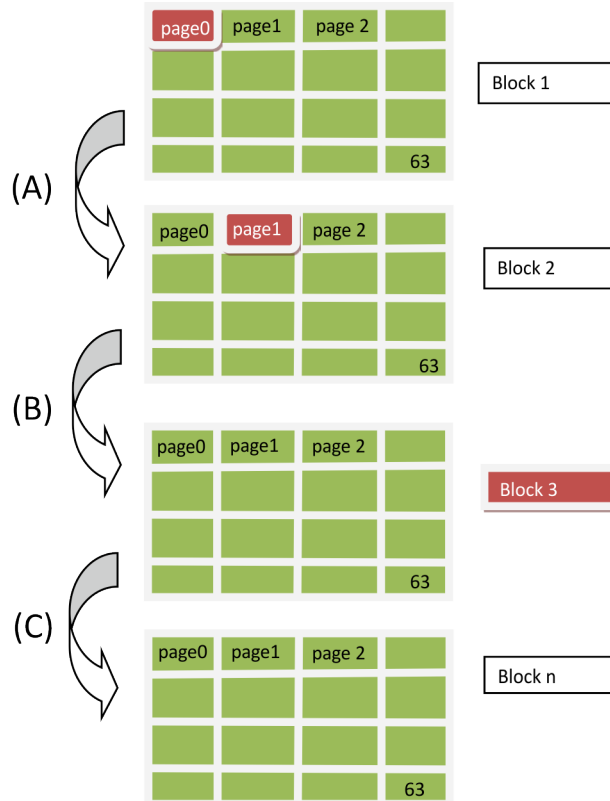
Figure 12. D800K008 ROM Behavior With Software Patch Applied⁽¹⁾

Once the patch is read, all subsequent page reads in the block will use the new ECC Correct and Read functions. ECC data errors on any page (other than page0) are ignored, any user data error (up to 4 bit errors total) is corrected and the boot process continues. If an uncorrectable error is detected on any page, the block is skipped and the boot process is restarted on the next good block. The behavior of the device boot from the NAND after application of the patch is shown in [Figure 12](#).

This workaround is implemented using a software patch that is loaded in device RAM at boot time and is designed to change the default behavior of the ECC Correct and Read functions in the RBL. The patch binary replaces function pointers to the ECC Correct and Read functions in the ROM function table, (defined in device internal memory), during boot. The patch binary will reside in page0 of the NAND block and so will be applied only after the page0 of a good block has been read.

- Page0 should be stored on multiple blocks as backup to take advantage of the safety mechanism built into Silicon Revision 2.1 to cycle to the next block when a page0 read fails in a good block.
- Maintain backup boot images in multiple blocks. The patch to the Abort function reinitializes the boot process and forces the boot to cycle to the next good block and restart the boot process by reading from it.
- Silicon Revision 2.1 supports booting from Block 0 of the flash which many NAND manufacturers guarantee as a “more reliable” block than all other blocks. Hence, setting up boot to start from that Block 0 could help improve the reliability of boot. This is a hardware change, requiring the bootmode pins BOOT[6:5] = 1x.

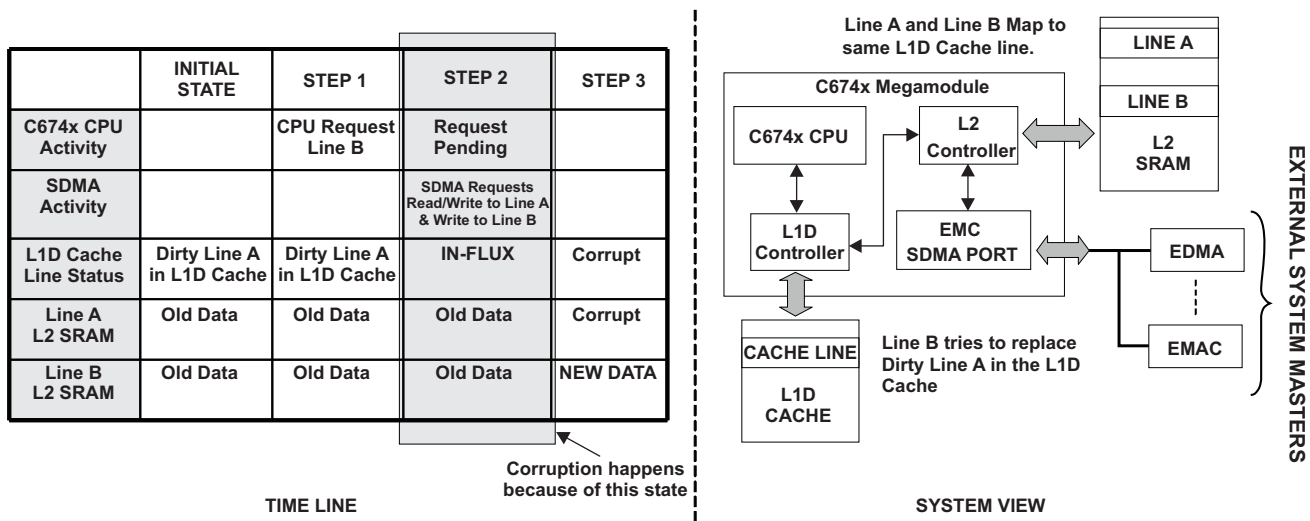
Figure 13. Example of L1D Cache and L2 RAM Corruption

1. L1D cache evicts a dirty line (Line A) while allocating a new line (Line B) in the same set/way (cache Lines A and B consist of 64-bytes each). In order for this to happen, the following will have taken place:
 - (a) Line A was previously read by CPU because L1D is a read-allocate cache,
 - (b) Line A is dirty because its value was modified by CPU, and
 - (c) Line B is read by CPU
2. Both Line A and Line B are associated with L2 RAM, and
3. While the original L1D victim write-back from condition (1) is in progress, the SDMA performs both:
 - (a) a read or write operation to Line A in L2 RAM and
 - (b) a write operation to Line B in L2 RAM.

If all of the above conditions are met, the L2 RAM data associated with the Line A victim writeback will become corrupt. Additionally, the Line B data originating from the SDMA write will also become corrupt in L1D cache. [Figure 13](#) shows an example scenario of L1D cache and L2 RAM corruption.
