F28M35x Concerto™ MCUs Silicon Errata Silicon Revisions E, B, A, 0

This document describes the silicon updates to the functional specifications for the F28M35x microcontrollers (MCUs).

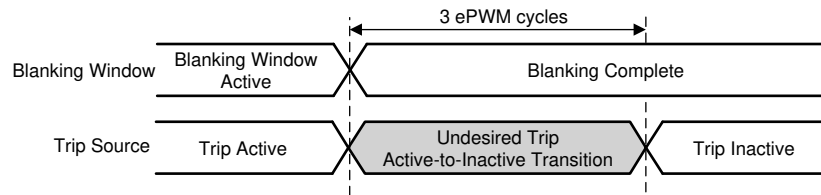
Figure 3. Undesired Trip Event and Blanking Window Expiration

Details The blanking window is typically used to mask any PWM trip events during transitions which would be false trips to the system. If an ePWM trip event remains active for less than three ePWM clocks after the end of the blanking window cycles, there can be an undesired glitch at the ePWM output.

Figure 3 illustrates the time period which could result in an undesired ePWM output.
