Errata

J721E DRA829/TDA4VM Processors Silicon Revision 2.0/1.1/1.0

ABSTRACT

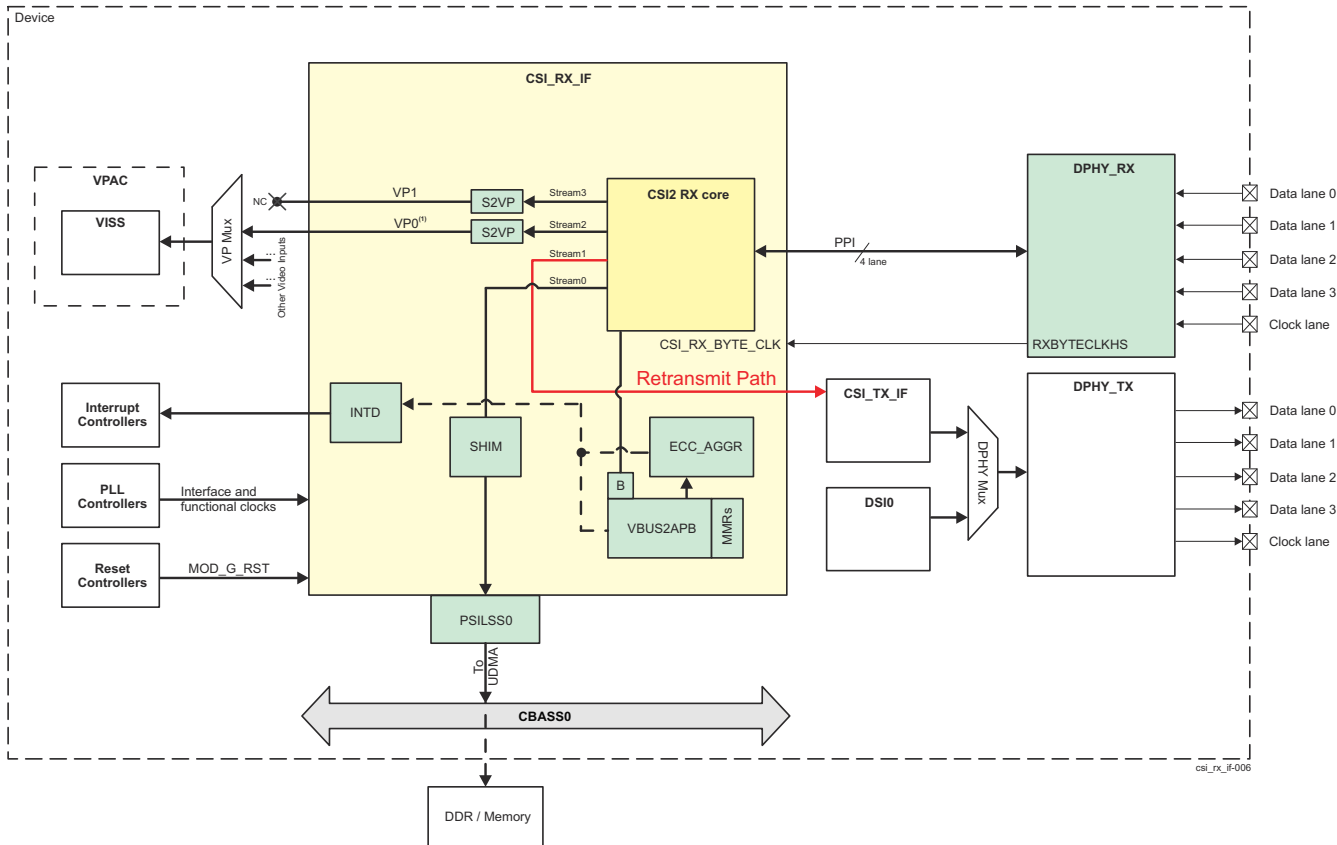
Figure 3-1. CSI_RX_IF Block Diagram

[Figure 3-1](#) shows CSI_RX_IF block diagram.

i2052 (continued) CSI: CSI-Rx to CSI-Tx Retransmit Path Is Unavailable

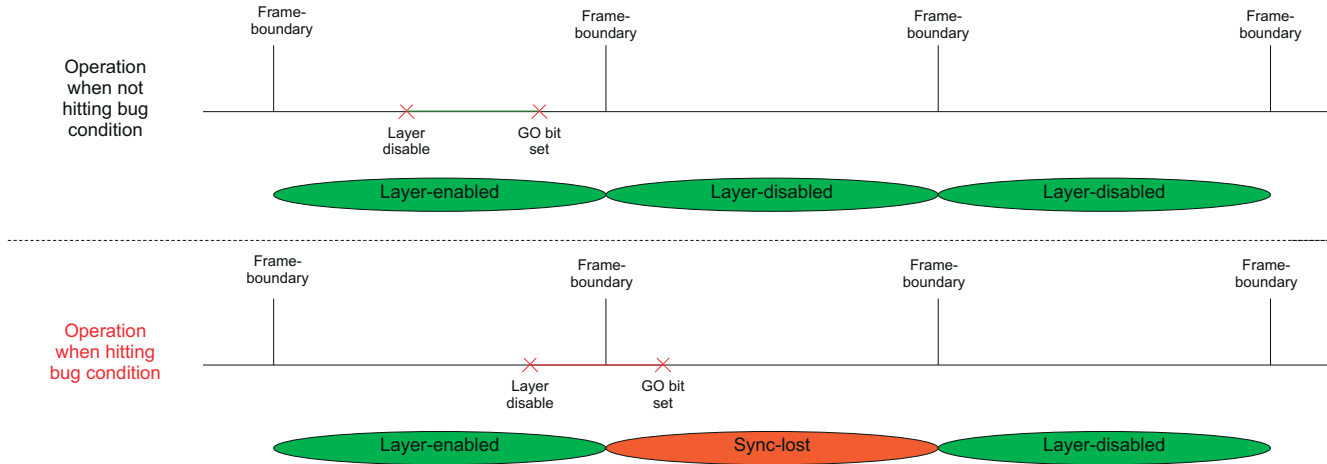
Figure 3-2. Bug Condition

DSS: Disabling a Layer Connected to Overlay May Result in Synclost During the Next Frame

of setting the GO bit (that is DSS_VP_CONTROL[5] GOBIT to 1) vis-à-vis the disabling of the layer. If the “disable layer” MMR write operation and “set GO bit” MMR write operation happens within the same frame boundary, no synclost occurs. If the operations happen across the frame boundary, then synclost occurs (for one frame). The design automatically recovers and returns to normal operation from the next frame after GO bit is set, see Figure 3-2.

Workaround(s):

A sample software workaround pseudo-code is shown on Figure 3-3. In this case, the regular “disable layer” MMR write operation and “set GO bit set” MMR write operation are replaced with macros which implement the software workaround.

- Replace layer disable MMR write operation with a macro which positions the layer to the non-visible area of the OVR
- Track which layers are disabled. This will be used while GO bit is set
- Replace GO bit set MMR write operation with this macro
- First, set GO Bit for the changes in “disable_layer” macro (and any other earlier changes) to take effect
- After the first GO bit set, few idle_cycles (10 DSS functional clock cycles) are necessary before we move to the second step
- In the second step, actually disable the layers based on the previously tracked information
- Set the GO bit for the second time for the disable of the layers to take effect
