Errata

J721E DRA829/TDA4VM Processors Silicon Revision 2.0/1.1/1.0

ABSTRACT

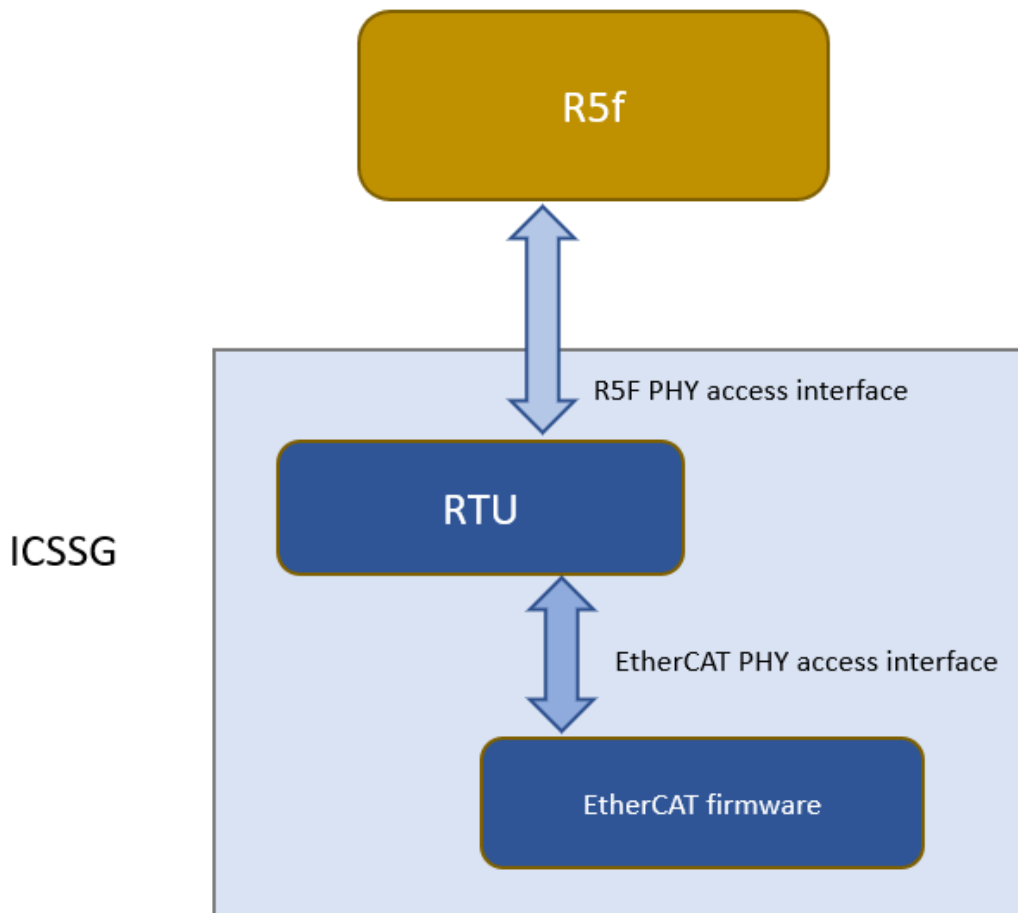
Figure 3-6. MDIO Emulation via Manual Mode using PRU Core

i2329 (continued) **MDIO: MDIO interface corruption (CPSW and PRU-ICSS)**

EtherCAT will continue to use PHY fast link detection via MDIO MLINK bypassing state m/c for link status (as this path is not affected by errata). This makes sure that cable redundancy related latency requirements are still met.
