Errata

# AM263x Sitara™ Microcontroller Silicon Revision 1.0A, 1.1

This document describes the known exceptions to the functional specifications (advisories). This document may also contain usage notes. Usage notes describe situations where the device's behavior may not match presumed or documented behavior. This may include behaviors that affect device performance or functional correctness.

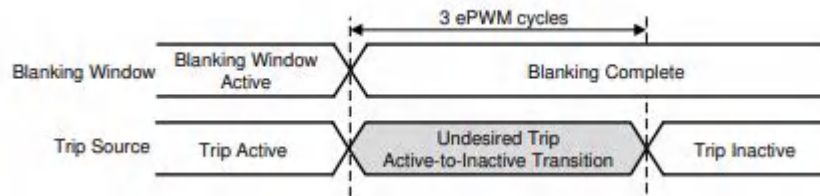
The blanking window is typically used to mask any PWM trip events during transitions which would be false trips to the system. If an ePWM trip event remains active for less than three ePWM clocks after the end of the blanking window cycles, there can be an undesired glitch at the ePWM output.

The following picture illustrates the time period which could result in an undesired ePWM output.

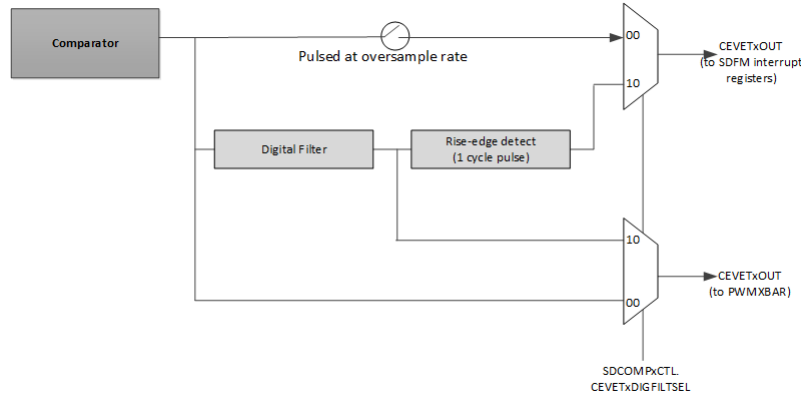
***SDFM module event flags (SDIFLG.FLTx\_FLG\_CEVTx) do not get set again if the comparator event is still active and digital filter path (using SDCOMPxCTL.CEVTxDIGFILTSEL) is being selected***

If SDFM digital filter is used in application the following workaround options can be considered:

- **Option 1**
  - XBAR status can be observed instead of the event flag register.
- **Option 2**
  1. After selecting the digital filter, wait for the interrupt/Trip.
  2. When the interrupt occurs, read the event flag and take appropriate application action to rectify the cause of comparator trip.
  3. Before clearing the event flag register, program the unfiltered path.
  4. Clear the event flag.
  5. Read the event flag and if it stays cleared for at-least one oversampling duration, reprogram the digital filter path.

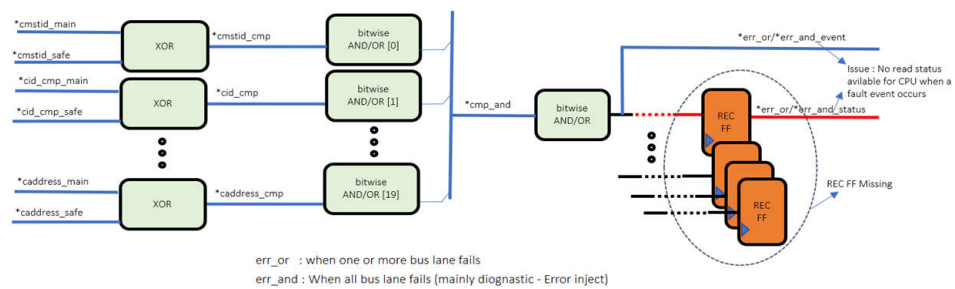
**Figure 3-2.**

Case 2: Log Registers have all zeros

Here the granular logs are not captured correctly and possible entities affected are R5F and L2 memory.

Case 2: In the case where the logs are not captured correctly then for a) diagnostics no action needed and b) in case of actual failure in the application WarmResethn should be used.

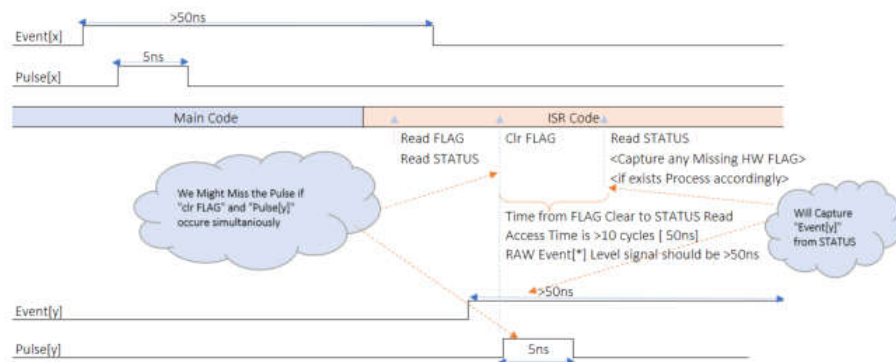
Potential race condition in capture registers resulting in events getting lost while other events in the same register are being cleared by writing to the register. Following registers are impacted by this issue:

Capture any missing HW event FLAG

If exists, process accordingly
