Errata

J784S4 AM69x TDA4VH TDA4AH TDA4VP TDA4AP J742S2 TDA4VPE TDA4APE Processors Silicon Revision 1.0

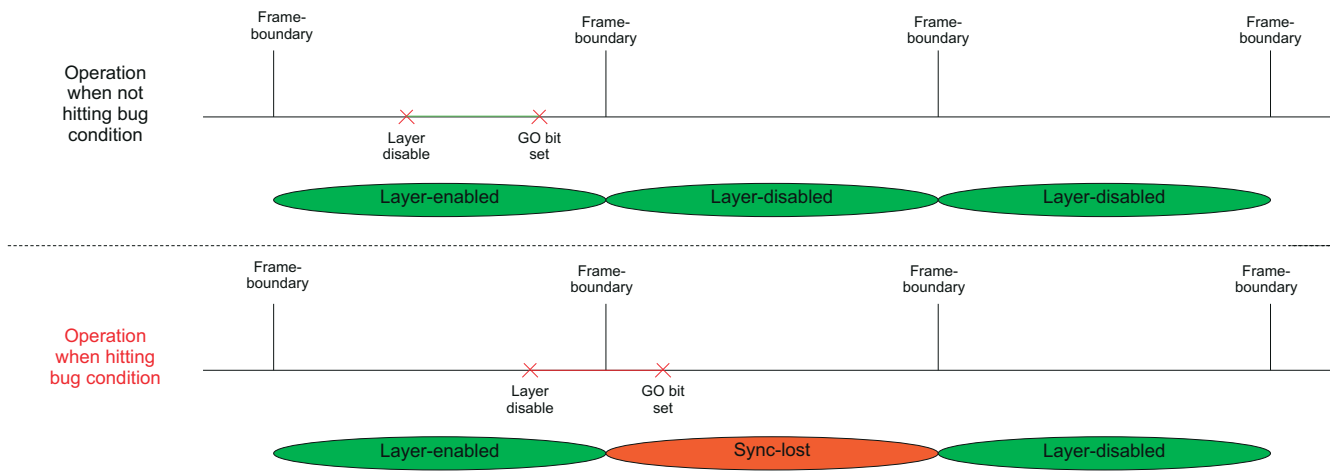
Figure 3-1. Bug Condition

Disabling a layer (for example VID1) connected to an OVR (that is toggling DSS_VID_ATTRIBUTESx[0] ENABLE from 1 to 0) may result in synclost during the next frame. The synclost may result in a corrupted or blank frame (all pixel data sent out of DSS during the frame is 0x0). The occurrence of synclost is dependent on the timing of setting the GO bit (that is DSS_VP_CONTROL[5] GOBIT to 1) vis-à-vis the disabling of the layer. If the “disable layer” MMR write operation and “set GO bit” MMR write operation happens within the same frame boundary, no synclost occurs. If the operations happen across the frame boundary, then synclost occurs (for one frame). The design automatically recovers and returns to normal operation from the next frame after GO bit is set, see [Figure 3-1](#).

A sample software workaround pseudo-code is shown on Figure 3-2. In this case, the regular “disable layer” MMR write operation and “set GO bit set” MMR write operation are replaced with macros which implement the software workaround.

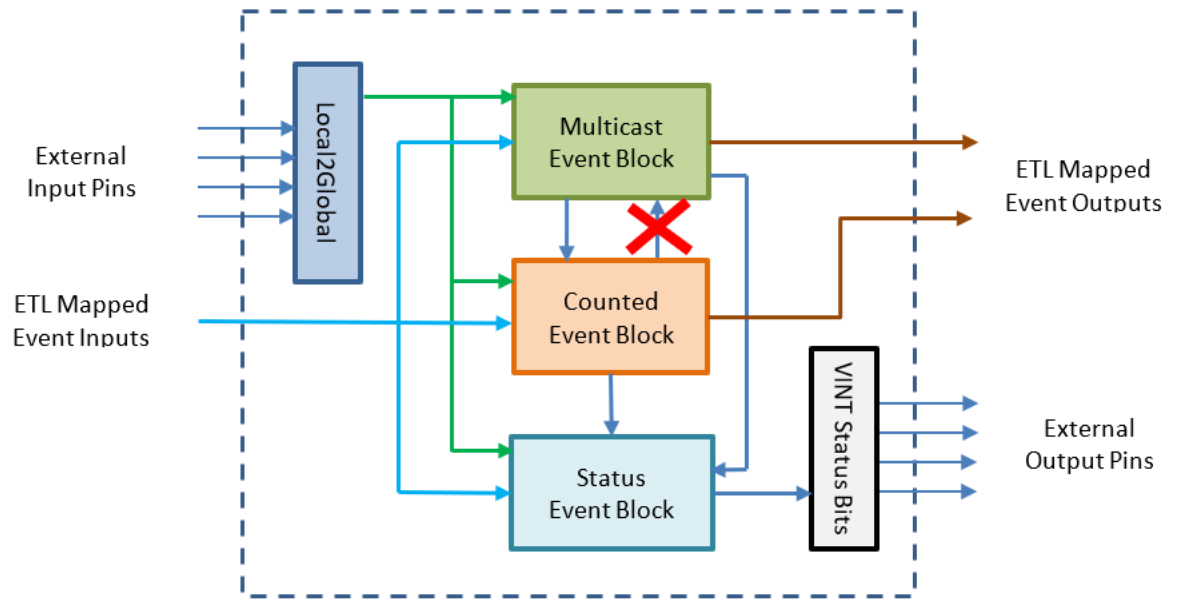
Figure 3-3. Interrupt Aggregator Version 1.0

An issue was found after design that could cause the IA to deadlock. The issue occurs when event “loops” occur between these three processing blocks. It is possible to create a situation where a processing block can not output an event because the path is blocked, and since it can not output an event, it can not take any new input events. This inability to take input events prevents the output path from being able to unwind, and thus both paths remain blocked.

[Figure 3-3](#) shows the conceptual block diagram of IA 1.0. Potential loops are avoided by adopting the policy of not allowing the counted event block to send events to the multicast block. This method was chosen because it is more common to split an event first, and then count one while sending the other elsewhere. With this path blocked by convention, it is not possible for a single event to visit any block more than once and thus not possible for paths to become blocked so long as the outputs remain unblocked.

By following the conventions outlined here, the system is safe from looping hazards that can create a deadlock scenario.
