Errata

F29H85x, F29P58x, and F29P32x Real-Time MCUs Silicon Errata (Silicon Revisions C, B, A, 0)

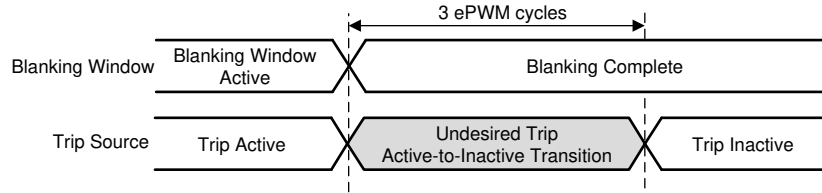
Figure 3-1. Undesired Trip Event and Blanking Window Expiration

Advisory *ePWM: An ePWM Glitch can Occur if a Trip Remains Active at the End of the Blanking Window*

The blanking window is typically used to mask any PWM trip events during transitions which would be false trips to the system. If an ePWM trip event remains active for less than three ePWM clocks after the end of the blanking window cycles, there can be an undesired glitch at the ePWM output.

Figure 3-1 illustrates the time period which could result in an undesired ePWM output.

Extend or reduce the blanking window to avoid any undesired trip action.

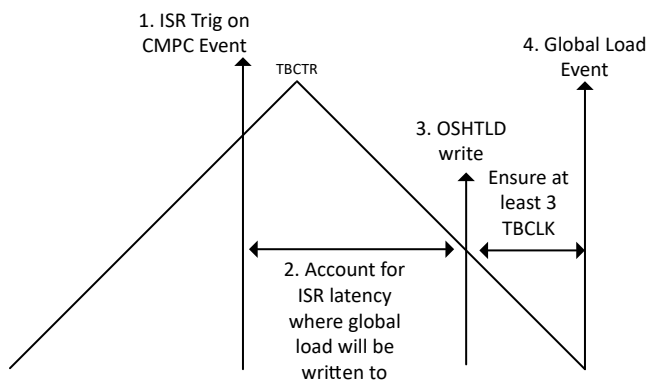
Figure 3-3. Example of Synchronous ISR Loading Method

Advisory *ePWM: For ePWMs Using Global Load in One-Shot Load Mode, Global Load of Registers may get Delayed When a Write to the GLDCTL2.OSHTLD Register Occurs Within 3 TBCLKs of the Global Load Event*

Details When a write to the GLDCTL2.OSHTLD register bit occurs within 3 TBCLKs of the global load event (configured by GLDCTL.GLDMODE), the global load of registers (configured by GLDCFG) may get delayed, which can create unintended waveforms.

Workaround To avoid this issue, any writes to the GLDCTL2.OSHTLD register bit needs to be a minimum of 3 TBCLK cycles before the configured global load event.

Workaround 1 (Recommended): Synchronous ISR to PWMs

1. Generate an ISR on a known Event Trigger Interrupt event (that is, CMPC, CMPD event, and so forth).
2. Ensure a minimum of 3 TBCTR cycles are kept between the global load event and when the ISR writes to GLDCTL2.OSHTLD.
 - a. When writing to the OSHTLD bit, ensure this is non-interruptible code by disabling the interrupts.

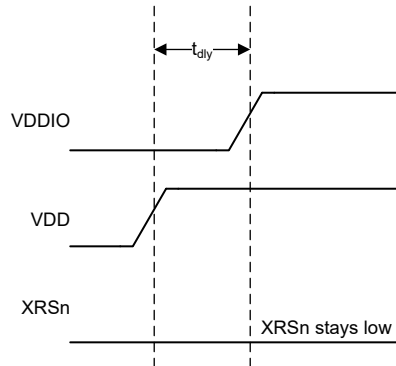
Figure 3-4. Incorrect Power-up Sequence Leading to Stuck Reset
Workaround

Advisory **System: Device Reset Remains Asserted When VDD Voltage Ramps Before VDDIO**
Revisions Affected 0, A, B, C

The device XRSn reset signal can remain in a low (reset asserted) state when the VDD supply voltage is ramped up before or simultaneously with the VDDIO supply. As a result, the device fails to boot.

Ensure the VDDIO supply is fully ramped up at least 1ms before ramping up the VDD supply voltage.
