Errata

AM62Px Sitara™ Processors Silicon Errata, Silicon Revision 1.0

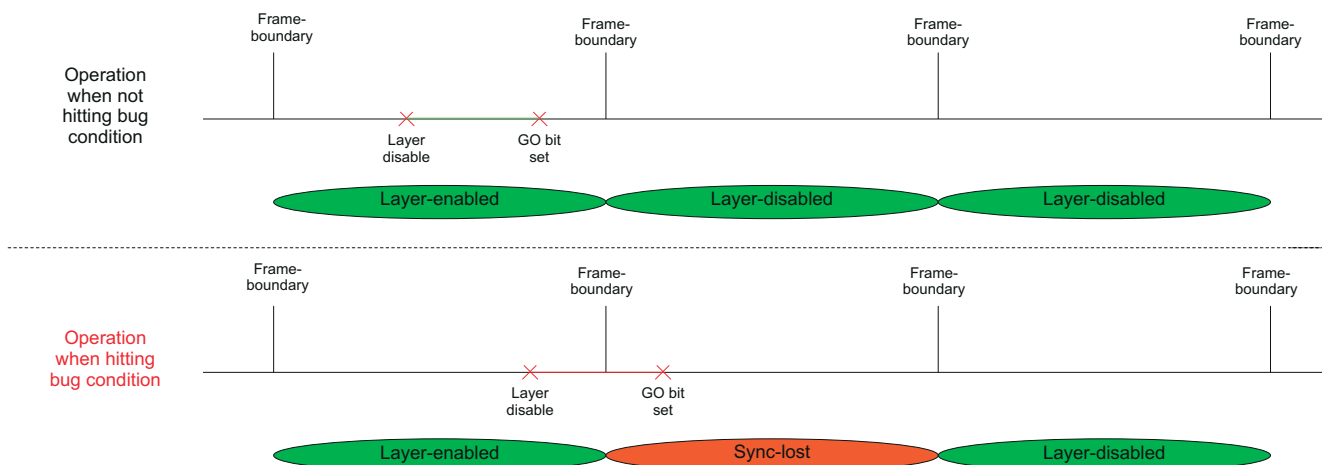
Figure 2-1. Bug Condition

i2097 **DSS: Disabling a Layer Connected to Overlay May Result in Synclost During the Next Frame**

Details: Disabling a layer (for example VID1) connected to an OVR (that is toggling DSS_VID_ATTRIBUTESx[0] ENABLE from 1 to 0) may result in synclost during the next frame. The synclost may result in a corrupted or blank frame (all pixel data sent out of DSS during the frame is 0x0). The occurrence of synclost is dependent on the timing of setting the GO bit (that is DSS_VP_CONTROL[5] GOBIT to 1) vis-à-vis the disabling of the layer. If the “disable layer” MMR write operation and “set GO bit” MMR write operation happens within the same frame boundary, no synclost occurs. If the operations happen across the frame boundary, then synclost occurs (for one frame). The design automatically recovers and returns to normal operation from the next frame after GO bit is set, see [Figure 2-1](#).

Workaround(s): A simple software workaround exists. In the workaround, prior to disabling a layer on the OVR, it is moved to the “non-visible” area of the OVR (for example: DSS_OVR_ATTRIBUTES_x[17-6] POSX = max_value_of_posx or DSS_OVR_ATTRIBUTES_x[30-19] POSY = max_value_of_posy). This avoids the synclost when the layer is disabled.

A sample software workaround pseudo-code is shown on [Figure 2-2](#). In this case, the regular “disable layer” MMR write operation and “set GO bit set” MMR write operation are replaced with macros which implement the software workaround.
