Errata

AM62Dx Sitara™ Processors Silicon Errata, Silicon Revision 1.0

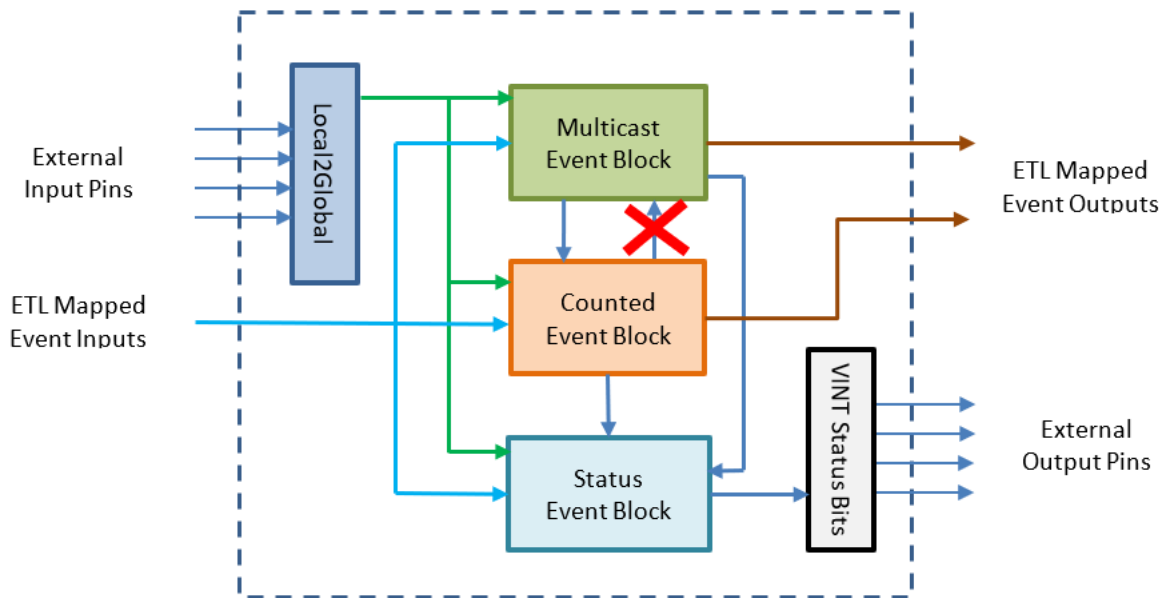
Figure 2-1. Interrupt Aggregator Version 1.0

An issue was found after design that could cause the IA to deadlock. The issue occurs when event “loops” occur between these three processing blocks. It is possible to create a situation where a processing block can not output an event because the path is blocked, and since it can not output an event, it can not take any new input events. This inability to take input events prevents the output path from being able to unwind, and thus both paths remain blocked.

Figure 2-1 shows the conceptual block diagram of IA 1.0. Potential loops are avoided by adopting the policy of not allowing the counted event block to send events to the multicast block. This method was chosen because it is more common to split an event first, and then count one while sending the other elsewhere. With this path blocked by convention, it is not possible for a single event to visit any block more than once and thus not possible for paths to become blocked so long as the outputs remain unblocked.

By following the conventions outlined here, the system is safe from looping hazards that can create a deadlock scenario.
