Errata

AWRL1432 Device Silicon Errata

Silicon Revisions ES1.1, ES2.0

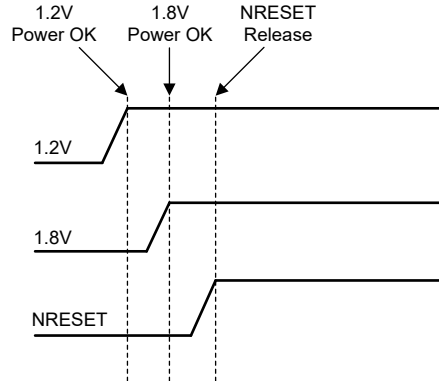
Figure 4-1. Recommended power up sequence

When the device is in power optimized topology and 1.8V powers up before 1.2V, a momentary large current can be seen at 1.2V rail before NRESET release only during the device power up. To avoid that, power up 1.2V (VDDIN, VDD_SRAM and VNWA) before 1.8V .

1. This usage note is ONLY applicable for 1.2V rail. For signals other than 1.2V power supply, refer the "Device Wake-up Sequence" diagram in the data sheet.
2. The power distribution network in TI EVM/Reference designs follows "Device Wake-up Sequence" in the data sheet and supports the additional current without powering up 1.2V first.

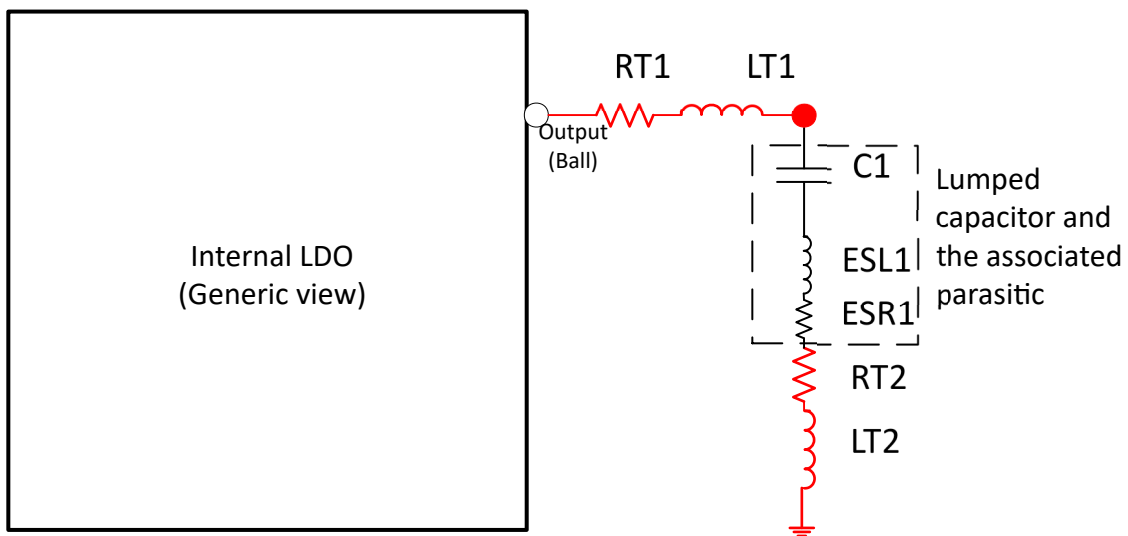
Figure 4-2. Single decoupling capacitor associated PCB parasitic

As indicated in the device data sheet, 1.2V Digital LDO requires one decoupling capacitor with a typical value of 4.7 μ F. The parasitic offered by different portion of the output path is illustrated in [Figure 4-2](#). "RT1" and "RT2" are parasitic resistances offered by the ball to capacitor lead trace and the ground trace, respectively. Similarly, "LT1" and "LT2" are parasitic inductances offered by the ball to capacitor lead trace and the ground trace, respectively. "ESL1" and "ESR1" are the effective series inductance and resistance of the decoupling capacitor. [Table 4-1](#) gives the minimum, maximum and typical values of the capacitance and the parasitic.

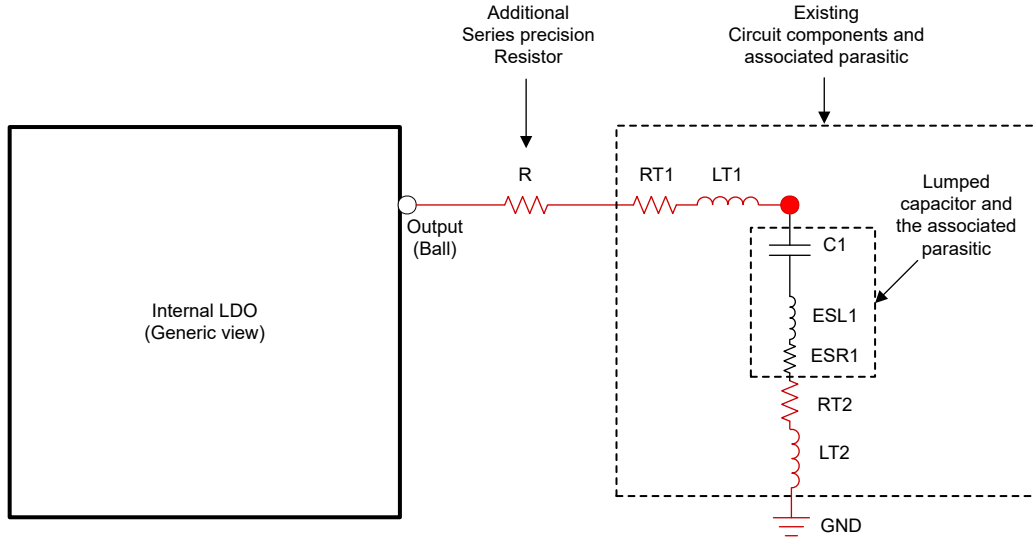
Figure 4-3. Example workaround

If the R_p is not achievable in PCB design, below workarounds can be considered:

Add a series precision resistor in the VDD output path along with the decoupling capacitor to get equivalent effective series resistance of the output path within the data sheet limits.

Example part no.: PA0402FRL570R02L, 20mOhm, 1% Tol.; MFL0603R0200FA, 20mOhm, 1% Tol;
