**ABSTRACT**

This document describes the known exceptions to the functional and performance specifications to TI CMOS Radar Devices (IWRL6432AOP )

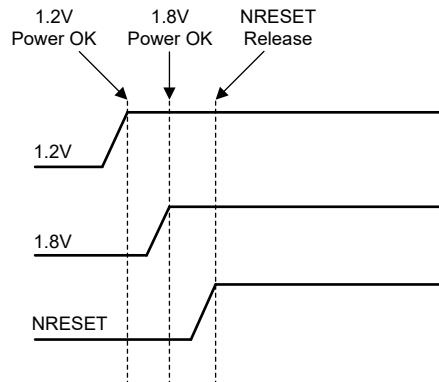
**Figure 4-1. Recommended power up sequence**

When the device is in power optimized topology and 1.8V powers up before 1.2V, a momentary large current can be seen at 1.2V rail before NRESET release only during the device power up. To avoid that, power up 1.2V (VDDIN, VDD\_SRAM and VNWA) before 1.8V .

1. This usage note is ONLY applicable for 1.2V rail. For signals other than 1.2V power supply, refer to the "Device Wake-up Sequence" diagram in the data sheet.
2. The power distribution network in TI EVM/Reference designs follows "Device Wake-up Sequence" in the data sheet and supports the additional current without powering up 1.2V first.

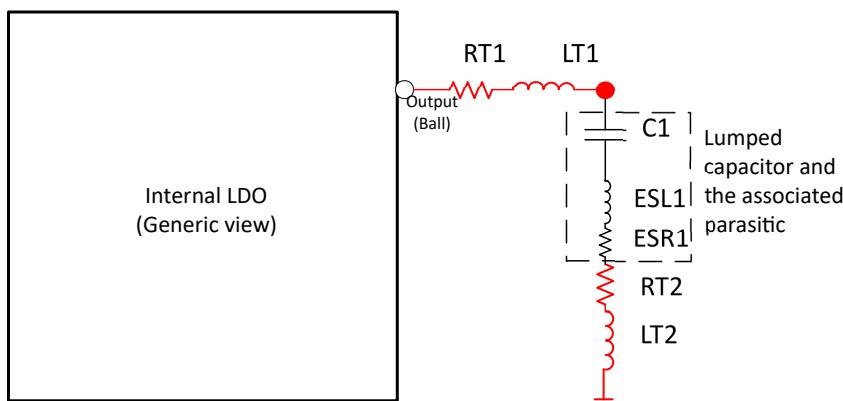
**Figure 4-2. Single decoupling capacitor associated PCB parasitic**

As indicated in the device data sheet, 1.2V Digital LDO requires one decoupling capacitor with a typical value of 4.7uF. The parasitic offered by different portion of the output path is illustrated in Figure 4-2. "RT1" and "RT2" are parasitic resistances offered by the ball to capacitor lead trace and the ground trace, respectively. Similarly, "LT1" and "LT2" are parasitic inductances offered by the ball to capacitor lead trace and the ground trace, respectively. "ESL1" and "ESR1" are the effective series inductance and resistance of the decoupling capacitor. Table 4-1 gives the minimum, maximum and typical values of the capacitance and the parasitic.

If the  $R_p$  is not achievable in PCB design, below workarounds can be considered:

Add a series precision resistor in the VDD output path along with the decoupling capacitor to get equivalent effective series resistance of the output path within the data sheet limits.

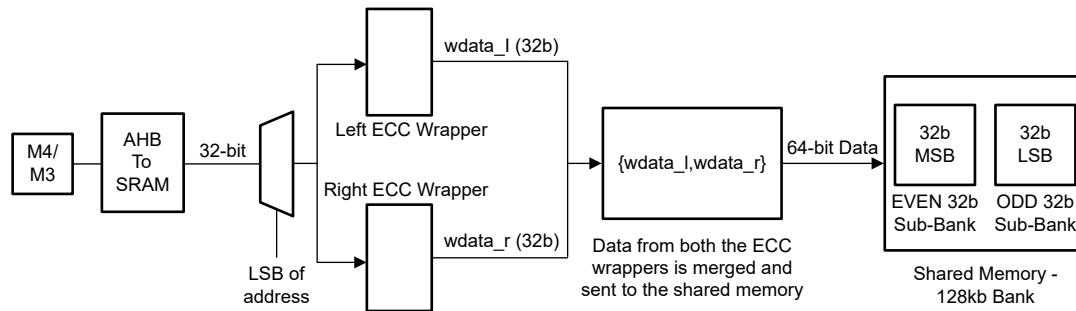
**Figure 6-1. Shared Memory Logic Diagram When Shared with M4/M3**

Internal shared memory has ODD and EVEN banking structure. For a particular address range, partial write (less than 32 bit) to EVEN bank corrupts same address of ODD bank with next data on the bus. When shared memory is allocated to M4/M3, back to back full word write access to location A followed by sub-word write access to location B corrupts data in location A.

When shared with M3/M4, the incoming data bit width is 32 bit as shown in the diagram. So, depending on LSB of address, signals are sent to either left or right ECC wrapper.

1. Use shared memories as code memory when shared with processor.
2. Disable ECC for non functional safety devices – ECC is disabled for shared memories in RBL for non functional safety devices.
