**TMS320C6671**  
**Multicore Fixed and Floating-Point Digital**  
**Signal Processor**  
**Silicon Revision 1.0, 2.0**

**Silicon Errata**

Literature Number: SPRZ366H  
October 2011–Revised June 2015

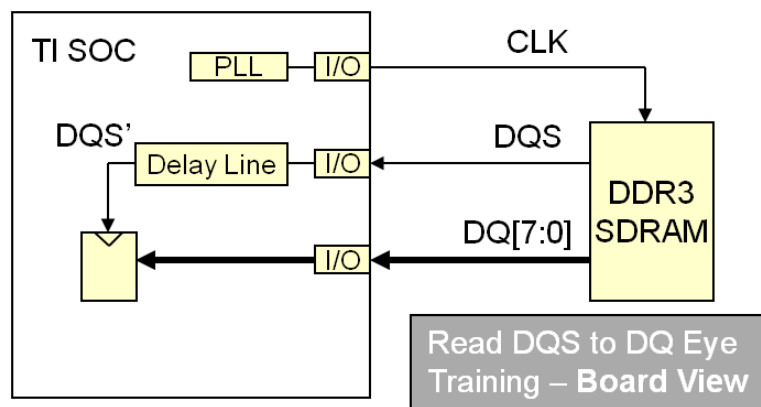
**Figure 2. Read DQS to DQ Eye Training - Board View**

The leveling feature with the problem is the Read Data Eye Training. Depending on the jitter seen on the DQ and DQS signals, this leveling feature will fail to converge on a good data eye, resulting in corrupted DSP to DDR3 SDRAM reads.

The intended purpose of the Read Data Eye Training feature is to align the DQS sampling transitions in the middle of the DQ data eye within individual byte lanes of the DDR3 memory interface. As seen in [Figure 2](#), the DQS signal can be delayed relative to the DQ signal within the DDR3 PHY.

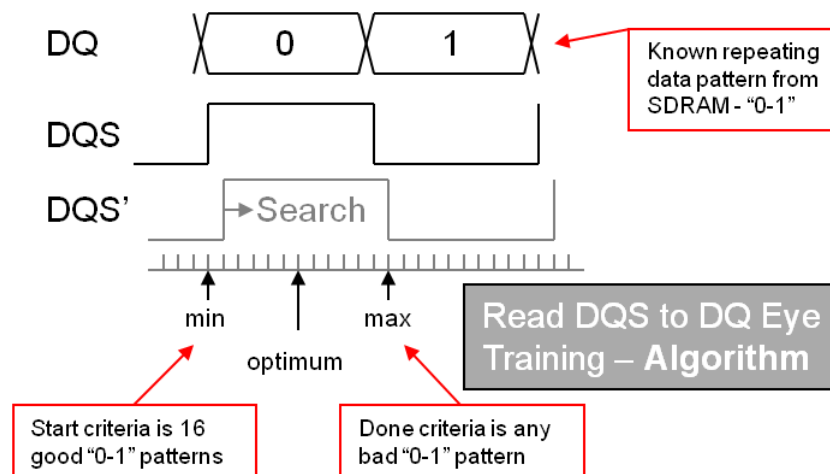
**Figure 3. Read DQS to DQ Eye Training - Algorithm**

As shown in [Figure 3](#), the Read Data Eye Training algorithm should correctly detect the extents of the DQ data eye. The SDRAM are put into a DQS to DQ eye training mode and read back an alternating 0, 1 pattern.

The DDR3 PHY uses this pattern to detect good or bad data being sampled by the DQS transitions. The DDR3 PHY searches by delaying DQS relative to DQ until these constraints are found.
