TMS320C6748 Fixed- and Floating-Point DSP Silicon Revisions 2.3, 2.1, 2.0, 1.1 and 1.0

Silicon Errata

Literature Number: SPRZ303H
June 2009–Revised March 2014

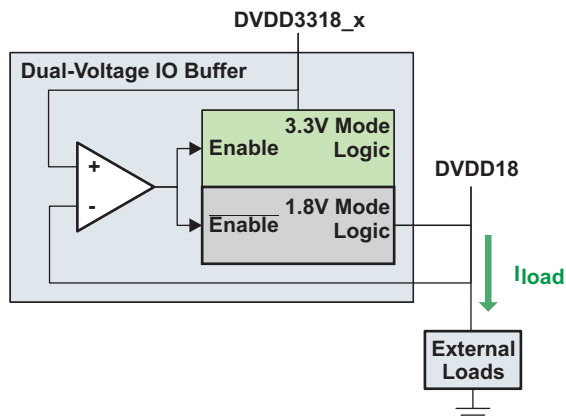
Recovered State of the IO buffer during Zone G:

If the load current is high enough or the DVDD18 power supply can oppose the leakage current, then the DVDD18 voltage stays low enough for:

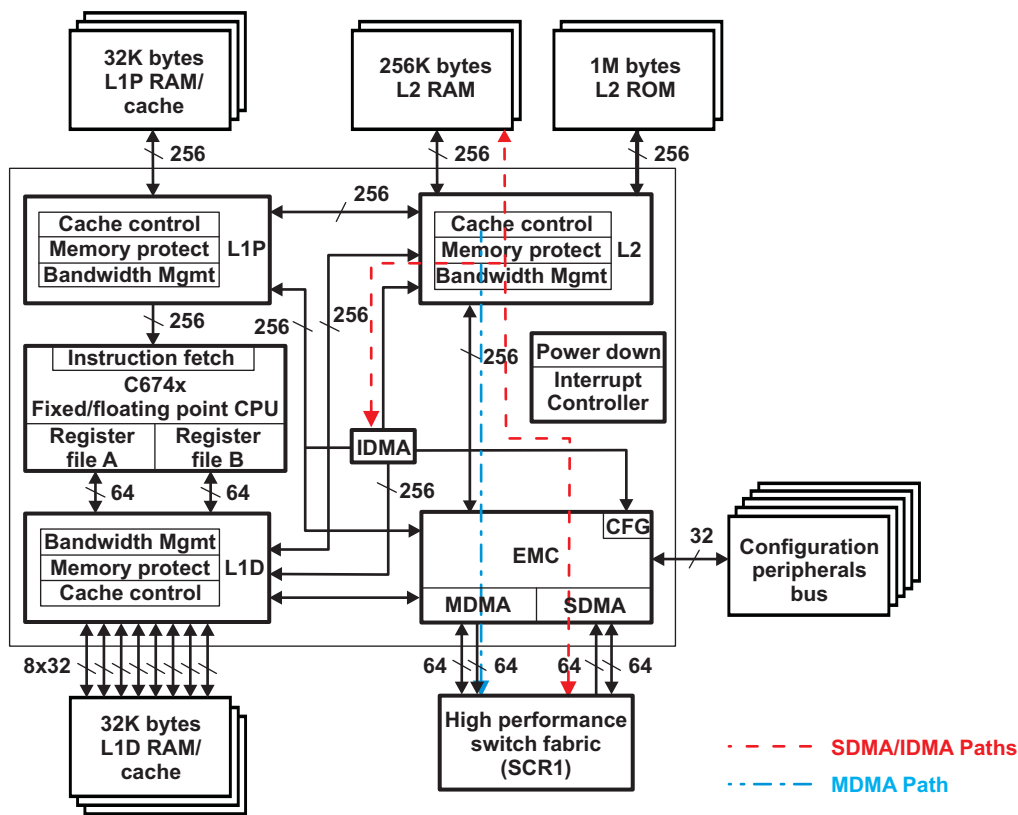
Figure 14. C674x Megamodule

Ideally, the MDMA (dashed-dotted line in Figure 14) and SDMA/IDMA paths (dashed lines in Figure 14) operate independently with minimal interference. Normally MDMA accesses may stall for extended periods of time due to expected system level delays (for example, bandwidth limitations). However, when using L2 as RAM, SDMA and IDMA accesses to L2/L1 may experience unexpected stalling in addition to the normal stalls seen by the MDMA interface. For latency-sensitive traffic, the SDMA stall can result in missing real-time deadlines. In a more severe case, the SDMA stall can produce a deadlock condition in the device. An IDMA stall cannot produce a deadlock condition.

Note: SDMA/IDMA accesses to L1P/D will not experience an unexpected stall if there are no SDMA/IDMA accesses to L2. Unexpected SDMA/IDMA stalls to L1 happen only when they are pipelined behind L2 accesses. Additionally, the deadlock scenario will be avoided if there are no SDMA accesses to L2.

Figure 14 is provided for illustrative purposes and is incomplete because of simplification. The IDMA/SDMA (dashed-lines) path could also go to L1D/L1P memories, and IDMA can go to DSP CFG peripherals. MDMA transactions can originate also from L1P or L1D through the L2 controller or directly from DSP).

The duration of the SDMA/IDMA stalls depend on the quantity/characteristics of the L1/L2 cache and the MDMA traffic in the system. Therefore, it is difficult to predict if stalling will occur and for how long.
