ABSTRACT

This document describes the known exceptions to the functional specifications (advisories).

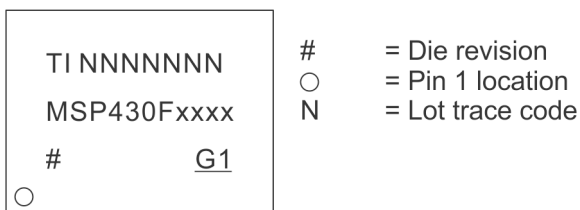
YFF49 *DSBGA (YFF), 49 Pin*

= Die revision
○ = Pin 1 location
N = Lot trace code

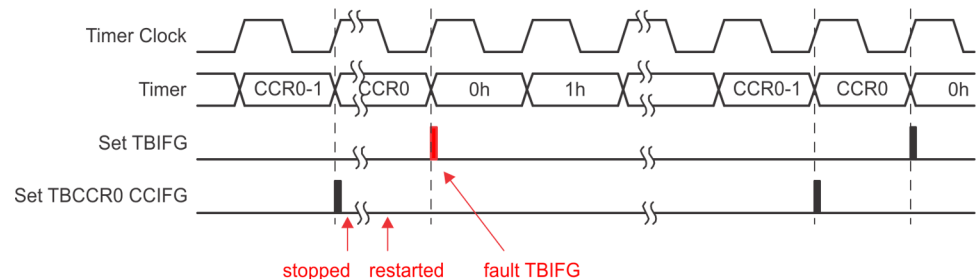
TB24 *TB Module*

Category	Functional
Function	TBIFG Flag is erroneously set after Timer B restarts in Up Mode
Description	In Up Mode, the TBIFG flag should only be set when the timer resets from TBCCR0 to zero. However, if the Timer B is stopped at TBR = TBCCR0, then cleared (TBR=0) by setting the TBCLR bit, and finally restarted in Up Mode, the next rising edge of the TBCLK will erroneously set the TBIFG flag.
