TMS570LS0232 Microcontroller

Silicon Revision B

Silicon Errata

Literature Number: SPNZ229A
March 2015–Revised May 2016

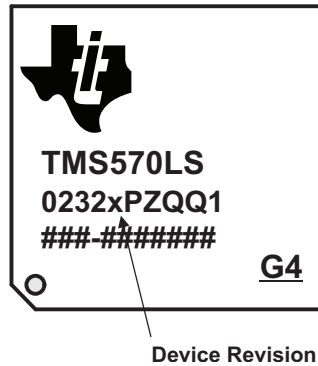
Figure 1. Device Revision Code Identification

[Figure 1](#) provides an example of the TMS570LSx device markings. The device revision can be determined by the symbols marked on the top of the package.

Silicon revision is identified by a device revision code. The code is of the format TMS570LS0232xPZQQ1, where "x" denotes the silicon revision. If x is "B" in the device part number, it represents silicon revision B. If the device uses the initial silicon version, no revision number is included.
