TMS320VC5410A
Digital Signal Processor
Silicon Errata

SPRZ187B
June 2001
Revised July 2002

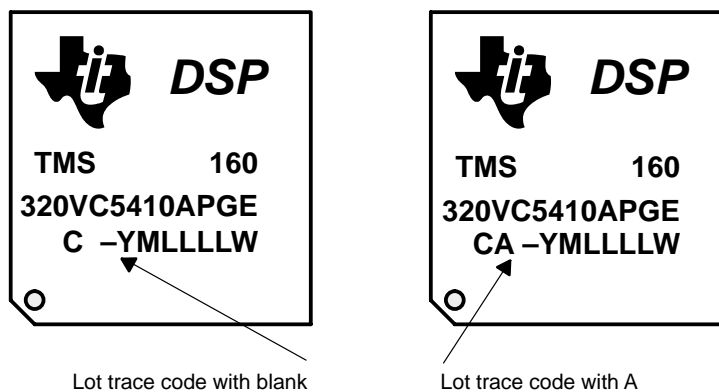
Figure 1. Example, Typical Lot Trace Code for TMS320VC5410A DSP (PGE)

The device revision can be determined by the lot trace code marked on the top of the package. The location for the lot trace codes for the PGE and the GGU packages are shown in Figure 1 and Figure 2, respectively.
