**AM387x Sitara™
ARM® Microprocessors (MPUs)
Silicon Revisions 3.0, 2.1**

Silicon Errata

Literature Number: SPRZ345C
September 2011–Revised March 2013

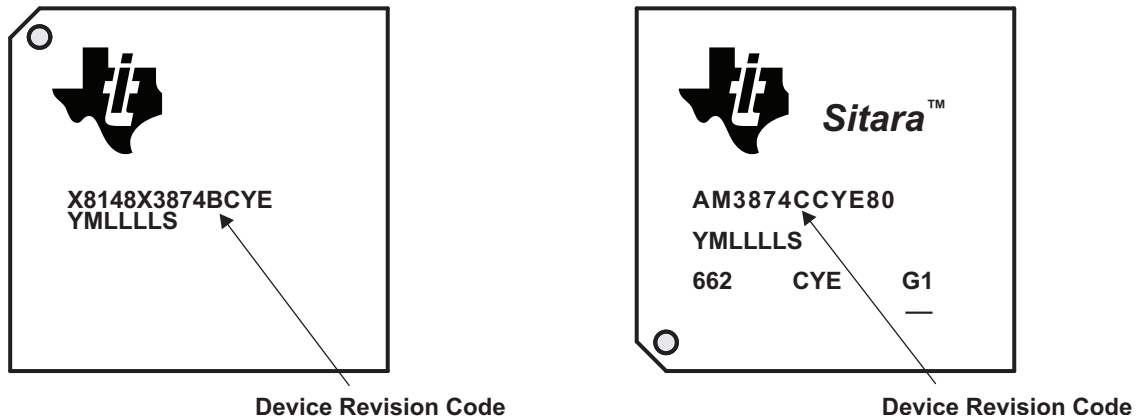
Figure 1. Example, Device Revision Codes for AM387x (CYE Package)

Figure 1 shows examples of the AM387x MPU package symbolization. The device revision can be identified by the markings on the top of the CYE package; the "B" or "C" between the device number and the package identifier indicates the device revision ("B" for silicon revision 2.1 and "C" for silicon revision 3.0), as noted in Figure 1.
