Errata

CC274xx-Q1 SimpleLink™ Wireless MCU Device Revision E

This document describes the known exceptions to functional specifications (advisories) of the CC274XX-Q1 SimpleLink™ device.

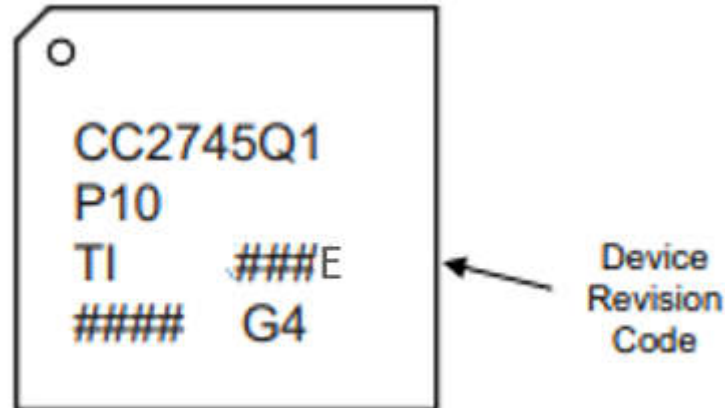
Figure 2-1. Package Symbolization

Package Symbolization and Table 2-1 describe package symbolization and the device revision code.
